# **BUILDING INSPECTION & CONDITION REPORT**

12 Brumby Court, Marlow Lagoon NT 0830

25th November, 2025

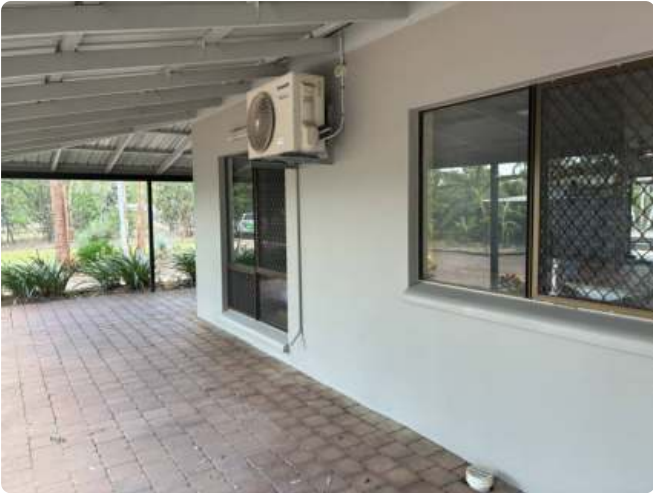
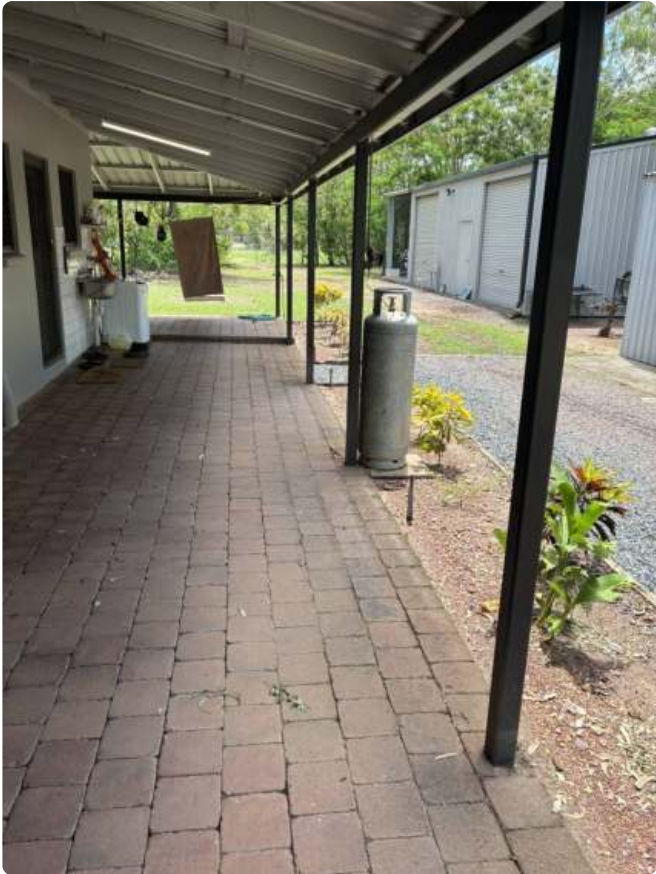
| Inspector Notes | Eaves and gutters appeared functional at the time of limited visual inspection. No obvious deterioration was visible from roof and ground-level viewing. Gutters exhibited visible debris accumulation restricting drainage. Clearing of debris is recommended to maintain effective water flow. |

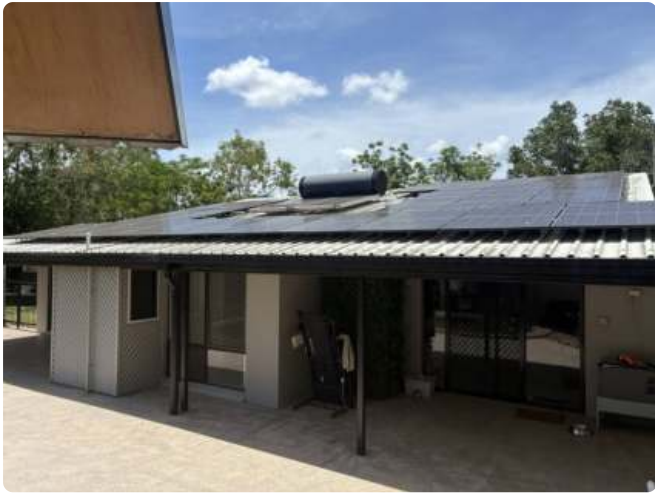
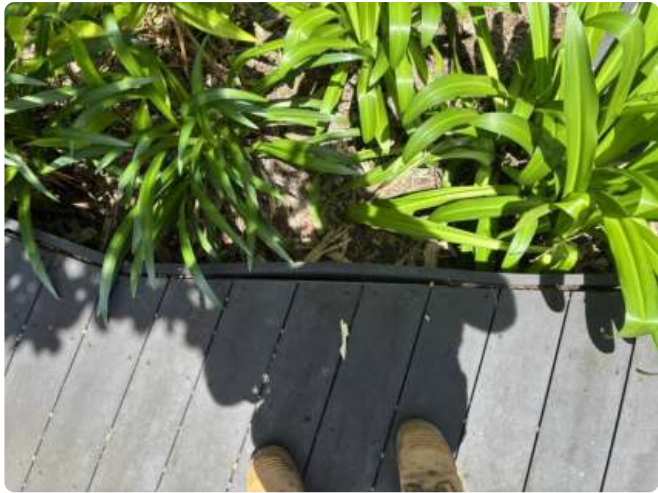
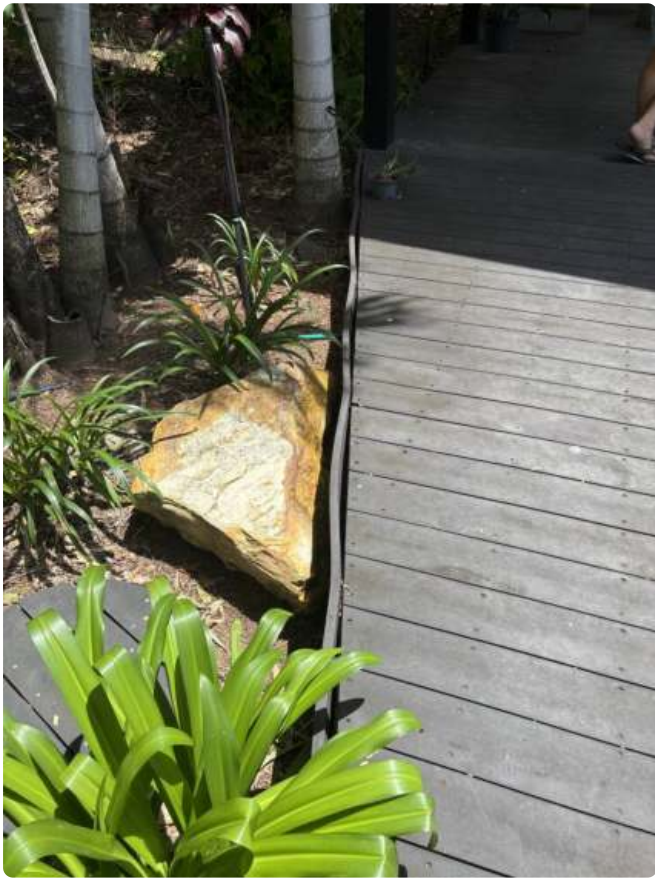
| Deck/Verandah | |
|---|---|
| Inspector Notes | Deck and verandah appeared functional at the time of inspection. Eco-board sections were visibly peeling. Further deterioration is possible if left unaddressed. |

Decking boarder is bowing and peeling away from subframe.

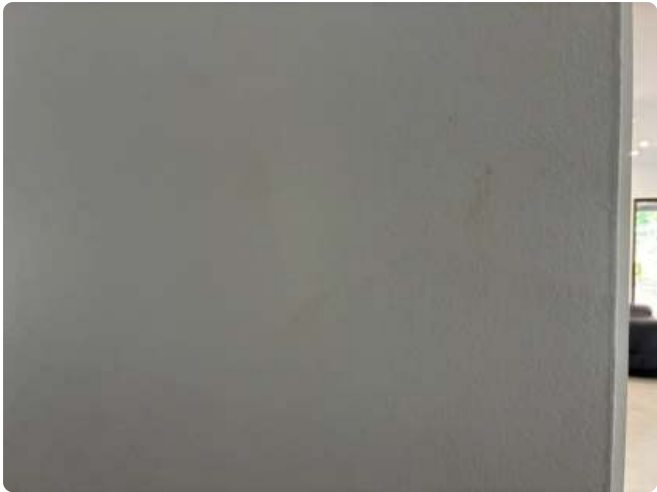
| Inspector Notes | Minor wall staining visible. No obvious movement or moisture indicators visible. |

Wall staining.

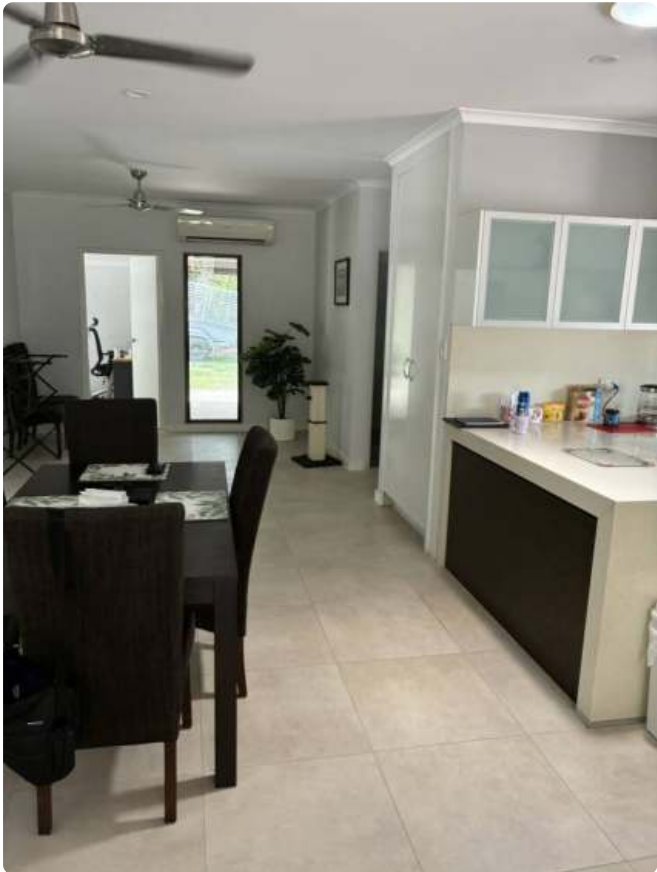
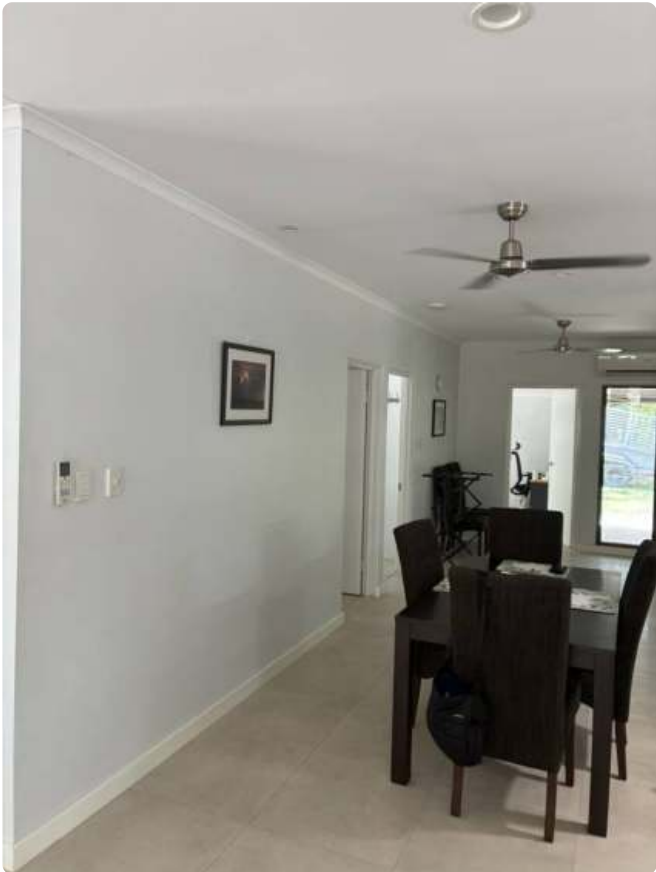
| Dining Room | |
|---|---|
| Inspector Notes | Localised paint peeling was visible. No moisture testing conducted, cause not determinable visually. |

Existing hole that has previously been patched has left the wall discolored.

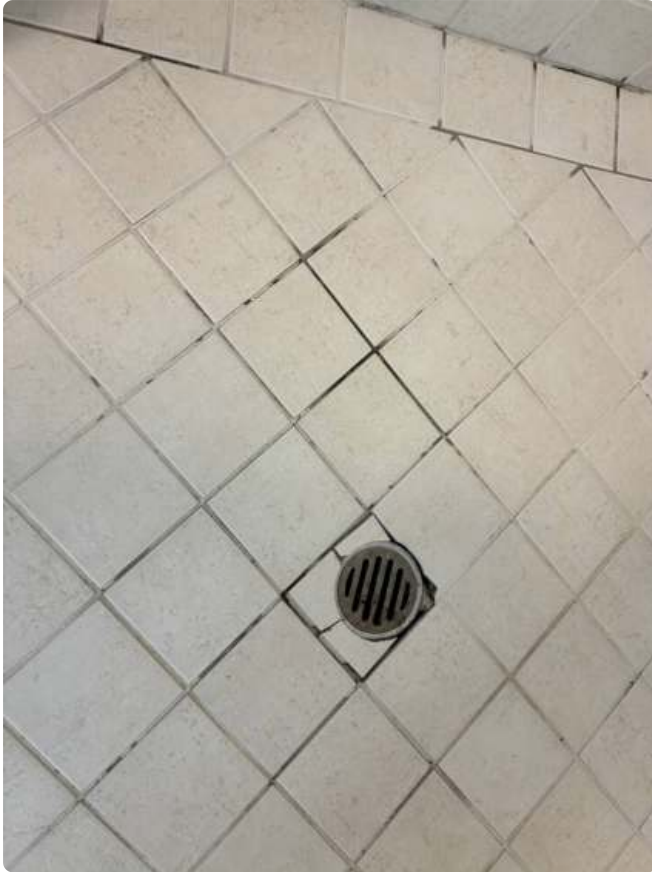
| Ensuite | |
|---|---|
| Inspector Notes | <p>The ensuite appeared to be in functional condition at the time of inspection, based on a limited visual assessment of accessible areas. A Significant Defect was identified in the shower wet area, where multiple cracked tiles were visible, particularly around the drain.</p> <p>Cracked tiles in a wet area present a potential moisture-ingress risk based on visual symptoms only; any concealed deterioration cannot be determined without invasive assessment. The shower screen was also heavy to operate and made contact with the basin when opened, indicating possible misalignment or hinge wear. Further evaluation and rectification by a suitably qualified tiler or waterproofing trade is recommended. No waterproofing or substrate assessment was undertaken.</p> |

Significant defect to flooring tiles on the surface of shower area.

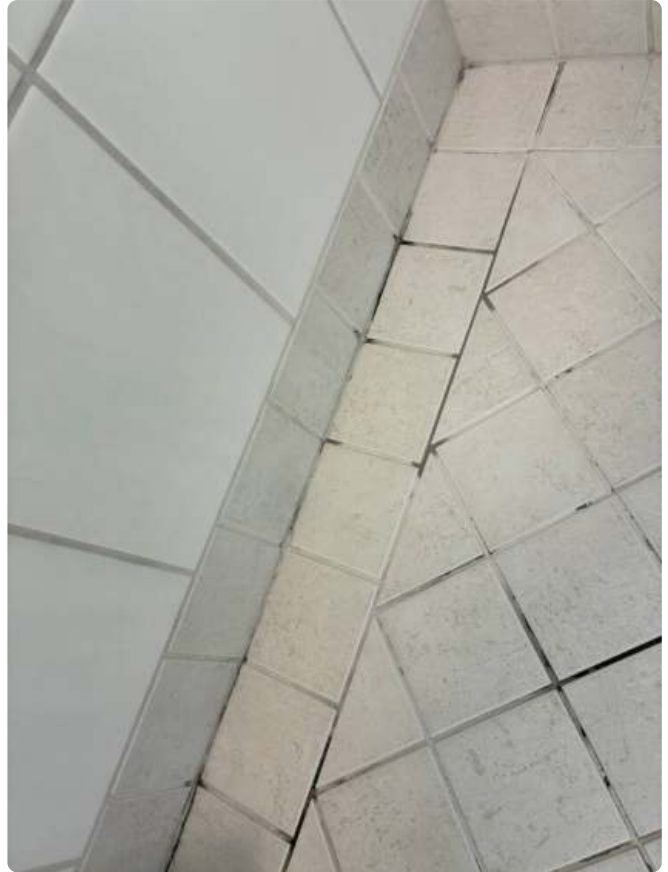
Significant defect to flooring tiles on the surface of shower area.

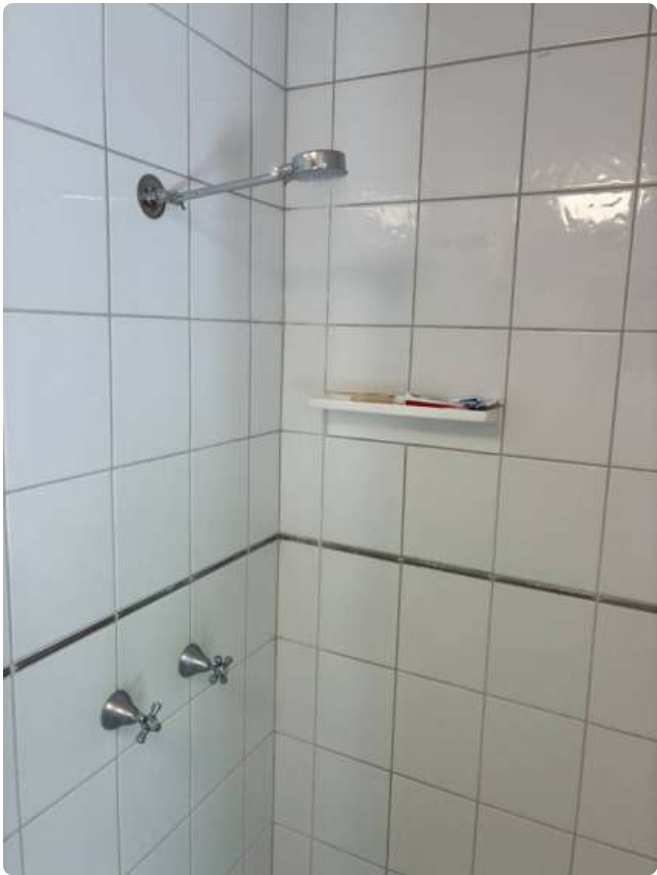
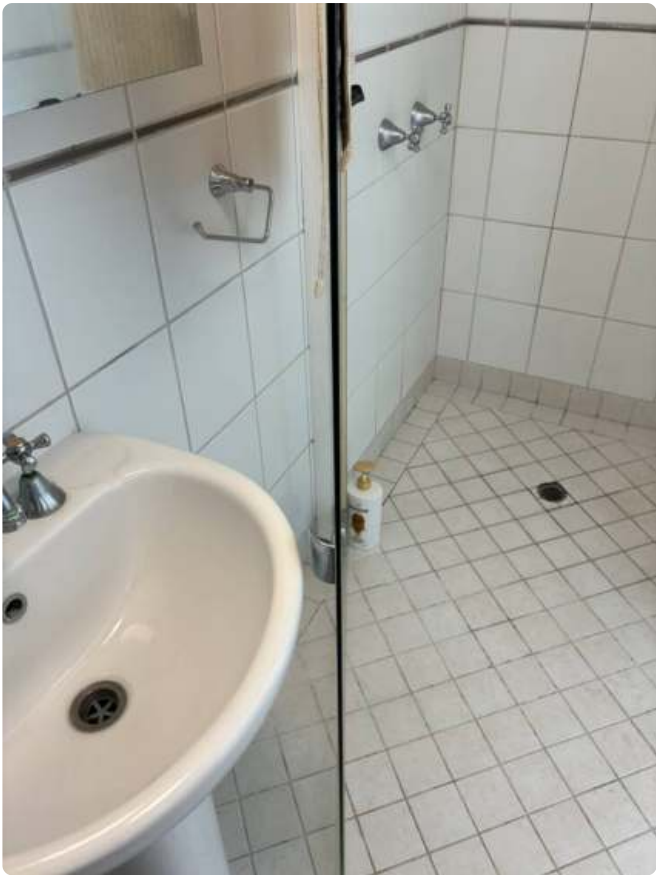
glass shower screen door opens into basin.

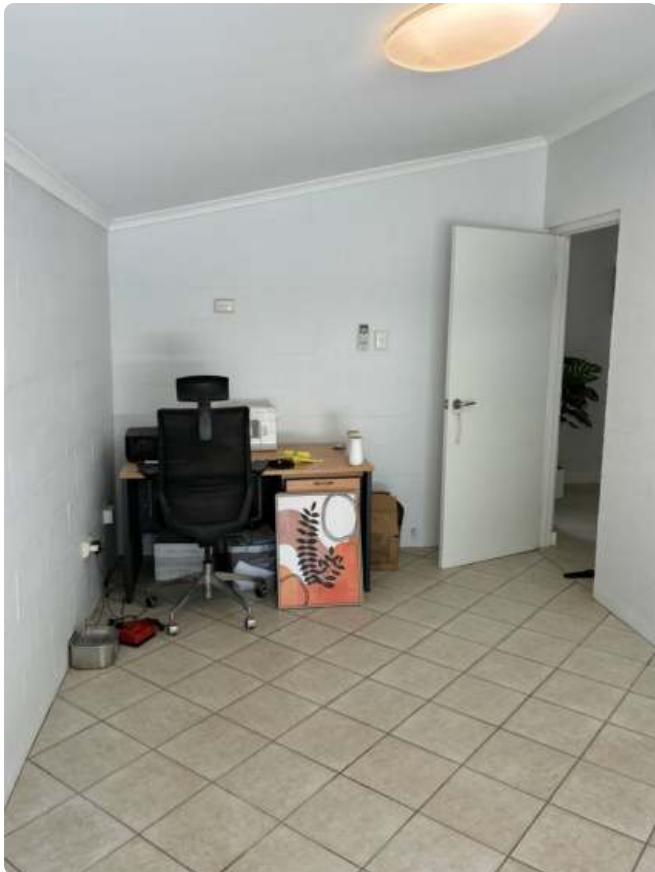
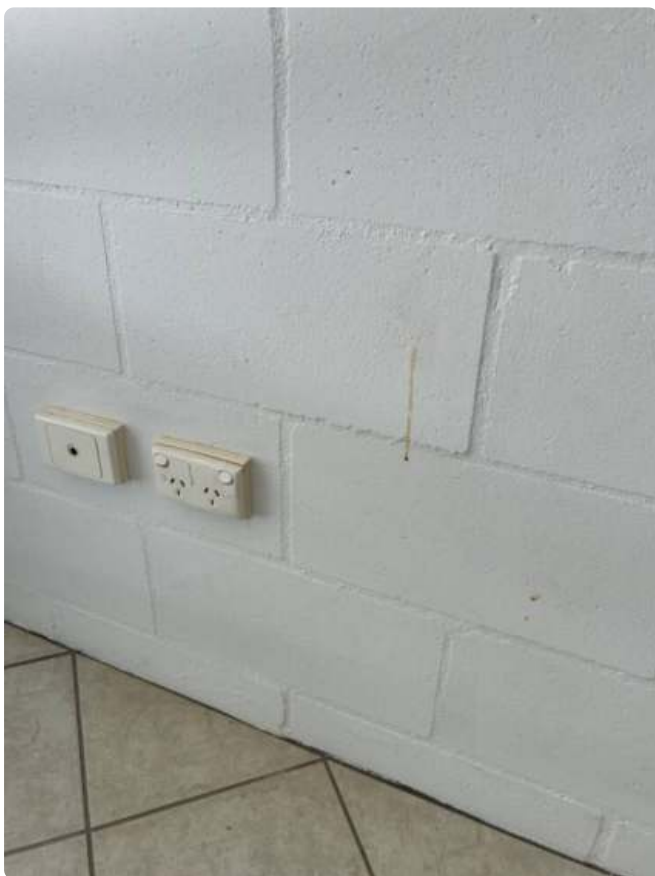
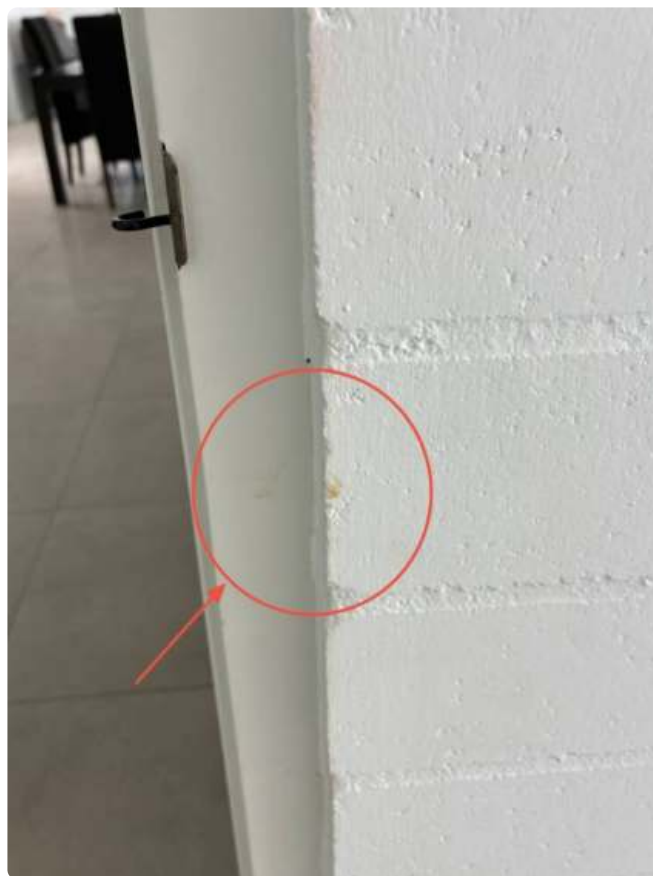
Minor staining on wall and door frame.
