# **BUILDING STATUS REPORT**

12 Brumby Court, Marlow Lagoon NT 0830

25th November, 2025

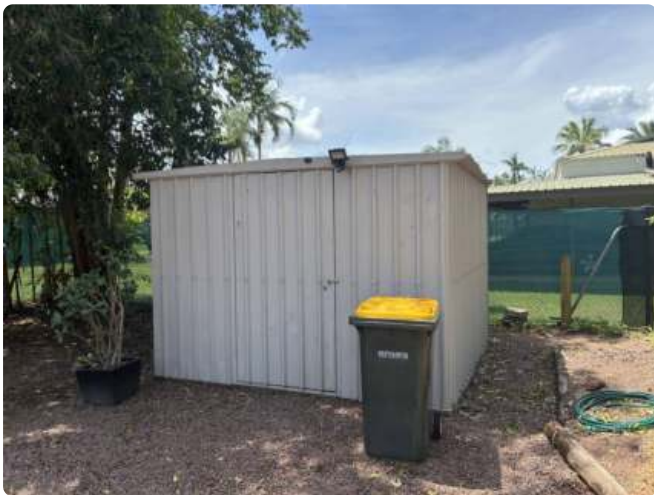
1. **Dwelling addition 590-4080-3** was cancelled after a "Permit to Build" was issued. No further documentation was available.
2. An **additional garden shed** was present onsite with **no corresponding documentation** in the BASB file accessed.

Garden shed - No documentation provided by BAS

- 1. Records Only:** No apparent inconsistencies were identified for structures supported by BASB documentation, based solely on visible comparison and without measurement or verification.
- 2. Garden Shed:** Seek clarification from BASB regarding approval status for the unrecorded shed, as records were not present in the BASB file accessed on 20/11/2025.
- 3. Future Works:** Ensure any future alterations or additions obtain the required Building Permit prior to commencement.
- 4. Essential Services:** Maintain servicing of essential services as required by any applicable Occupancy Permit.
