# VISUAL PLUMBING REPORT

12 Brumby Court, Marlow Lagoon NT 0830

25th November, 2025

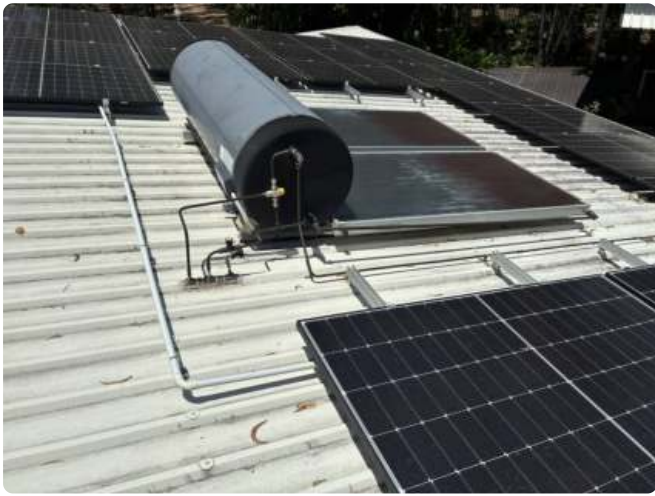
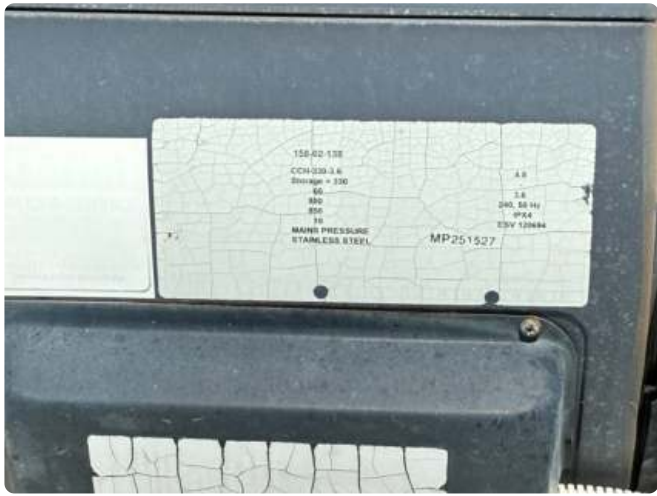
| Hot Water Unit | |
|---|---|
| Inspector Notes | Hot water unit appeared to be serviceable at the time of inspection. |
| Condition | Good Condition |
| Location of Hot Water Unit | Roof |

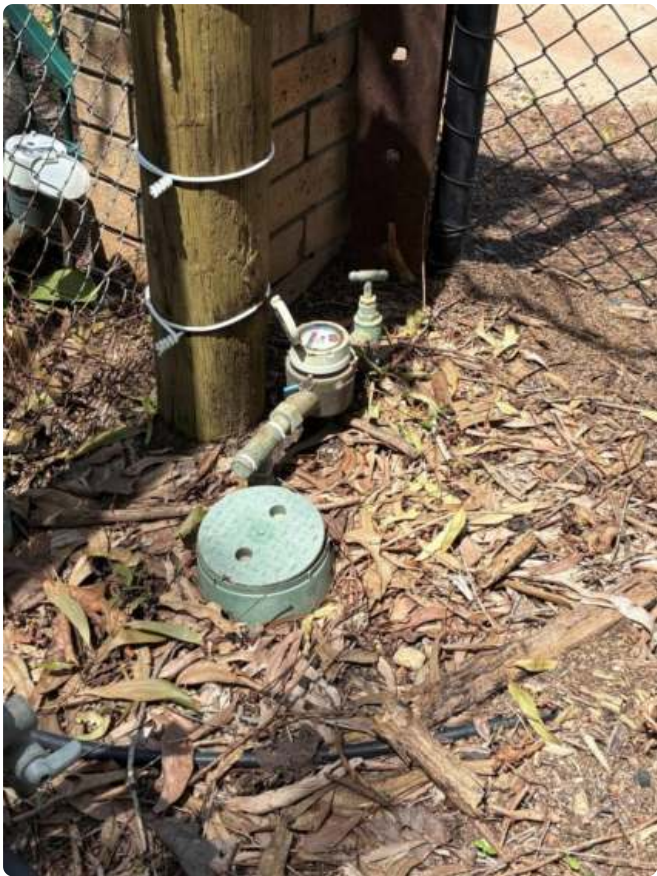
Water Supply - Continued

| General Observations | |
|---|---|
| Observations | Water supply appeared to be in serviceable condition at the time of inspection. |
| Recommended Actions | The visible water supply lines appeared intact at the time of limited visual inspection. No active leaks were visible in accessible areas. This assessment does not confirm pressure performance, flow rate, pipe integrity within walls or underground, compliance with NT plumbing standards. Any hidden or intermittent failure cannot be identified without specialised testing. |

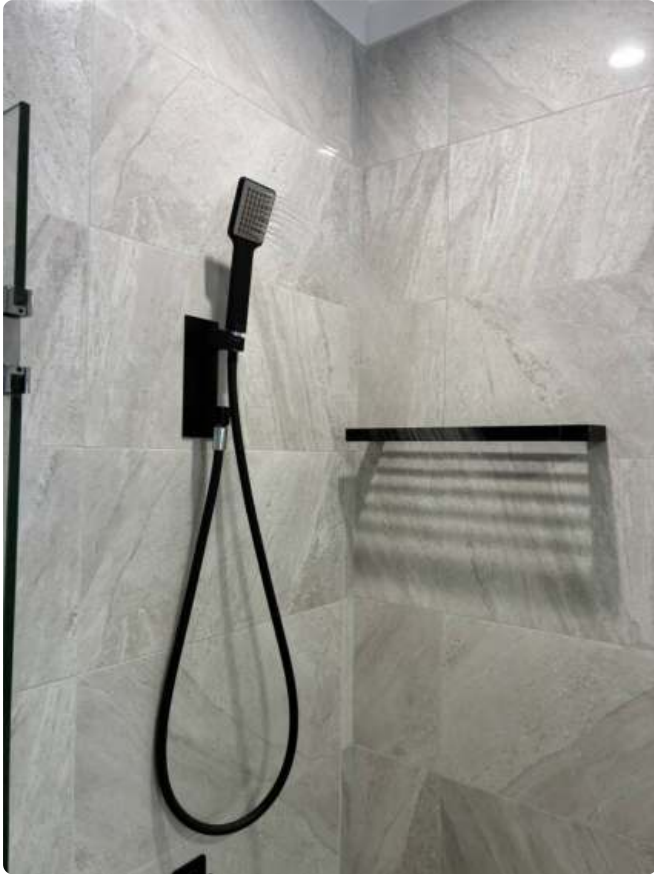
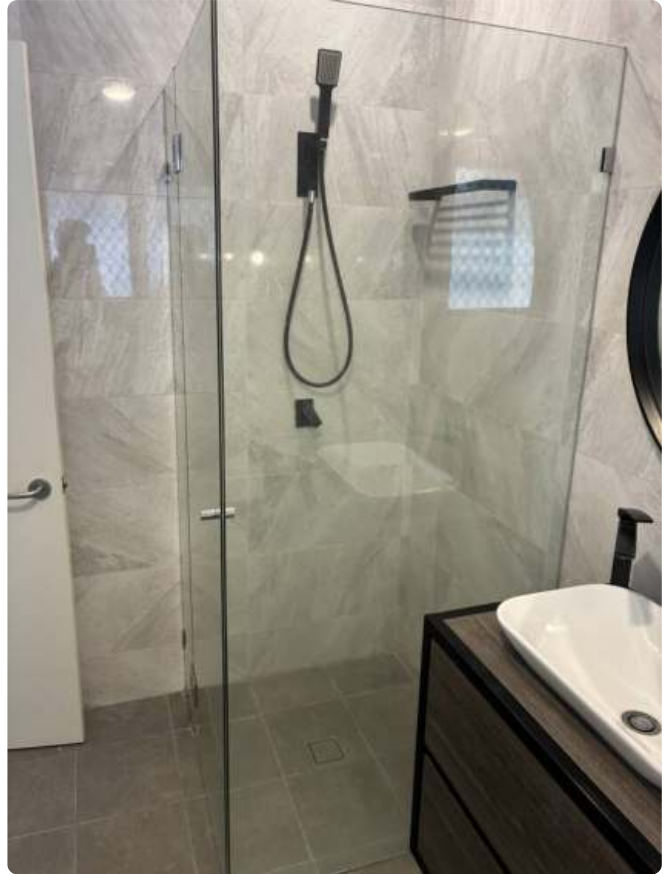
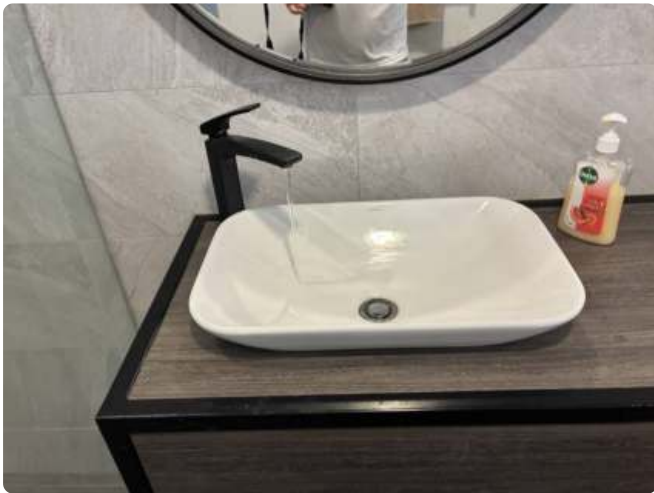
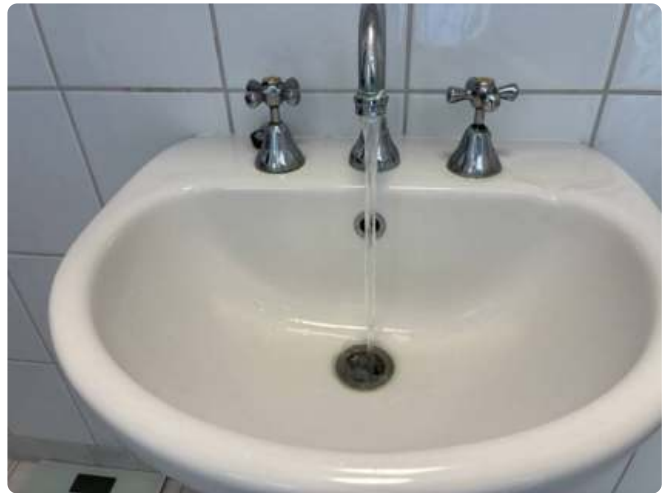
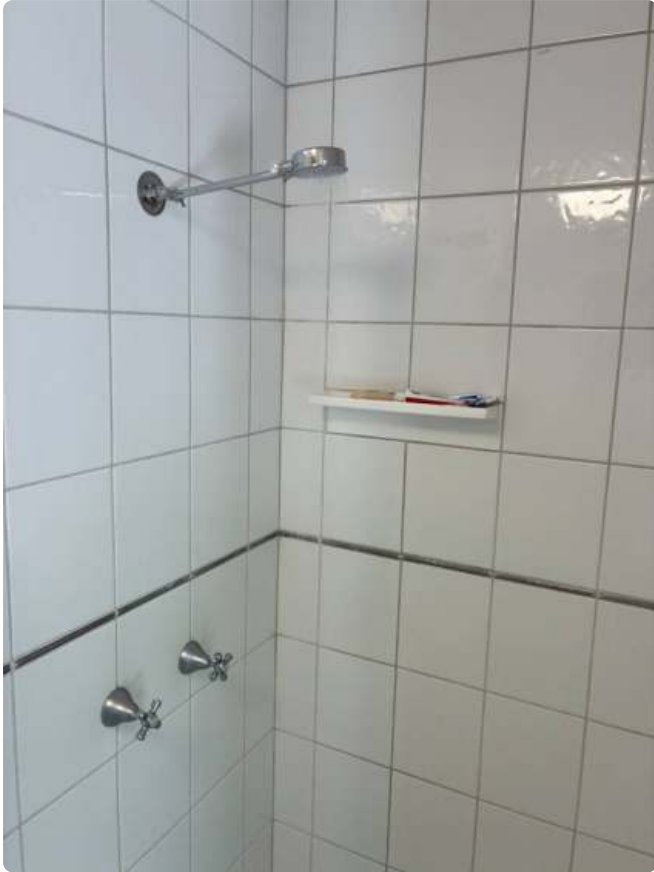
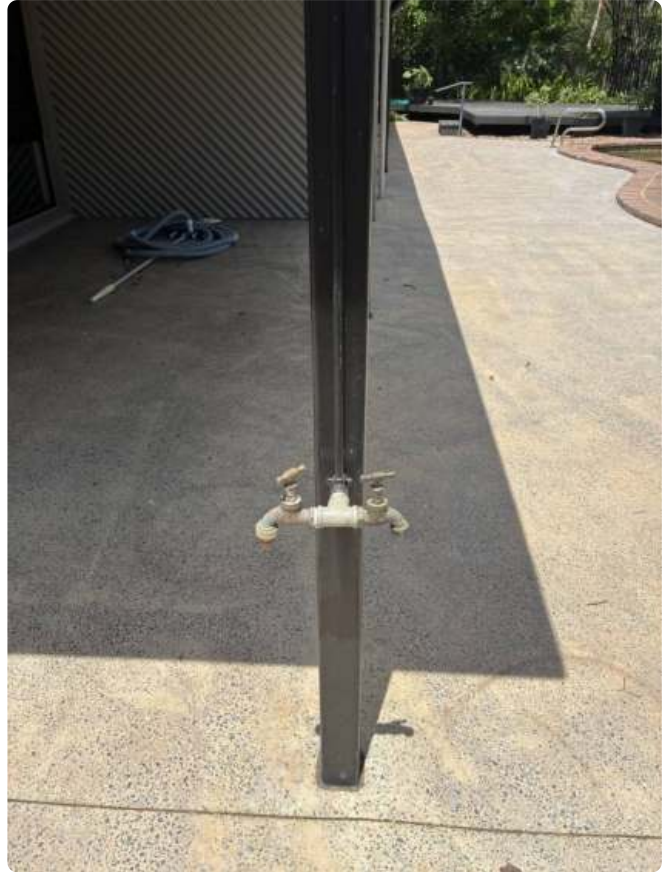
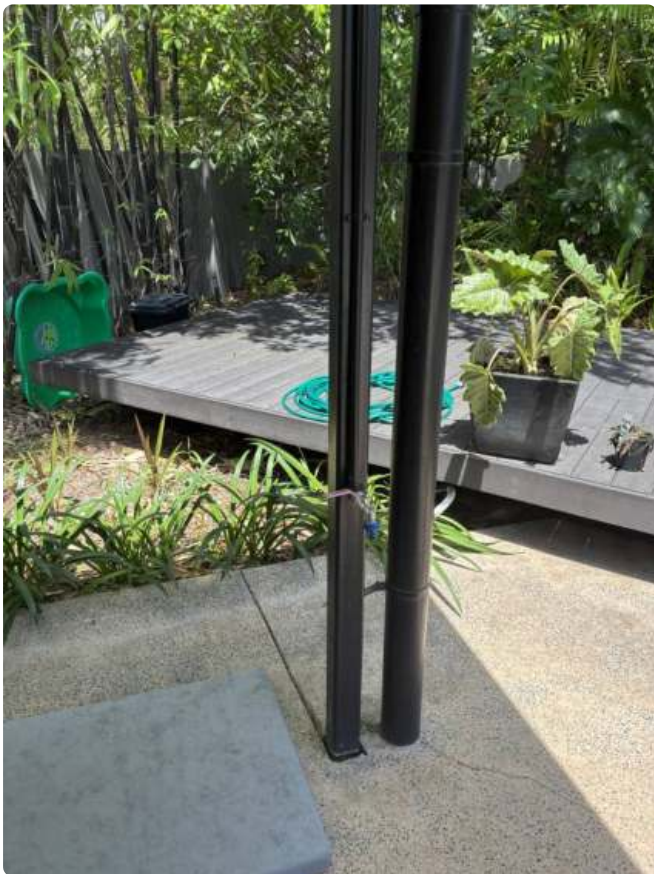
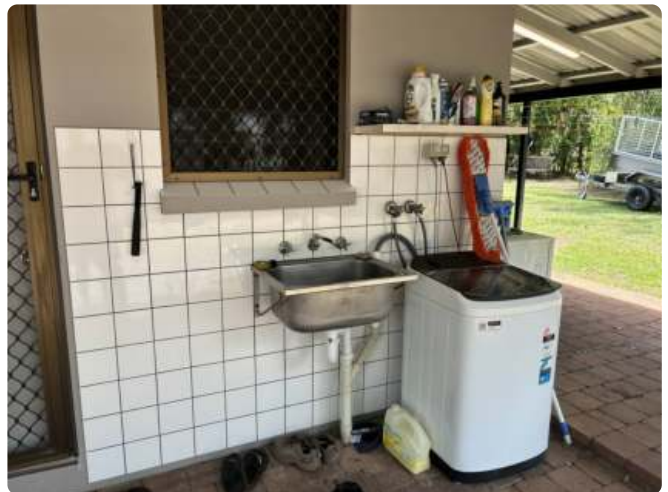
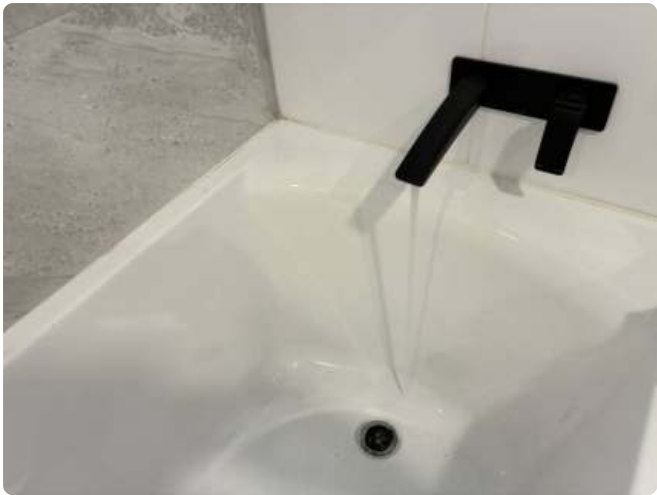
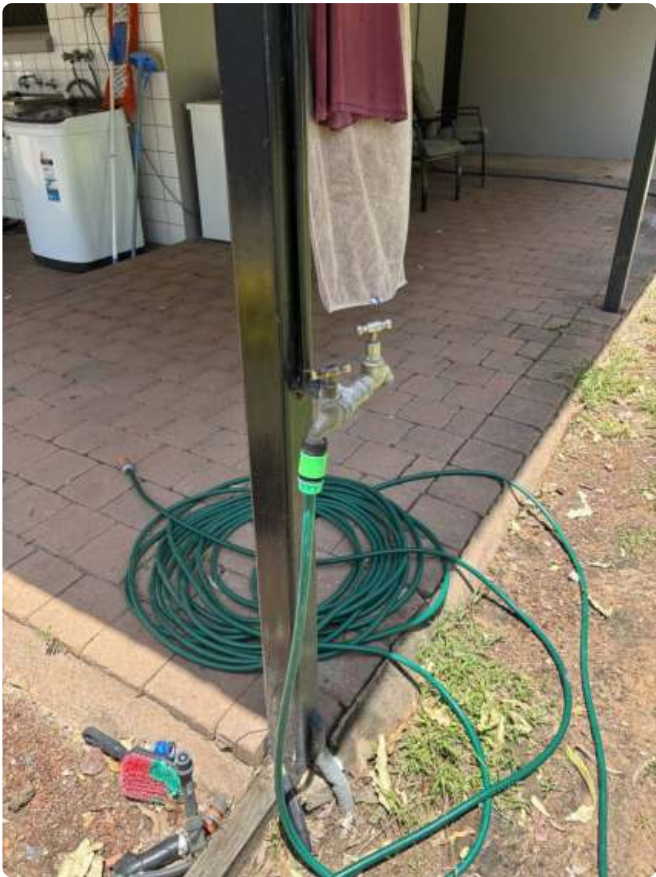
Taps and fixtures appeared operational under basic visual operation only (on/off observation). No performance, pressure, or seal-integrity testing was conducted. Minor wear consistent with use was visible on selected fittings.

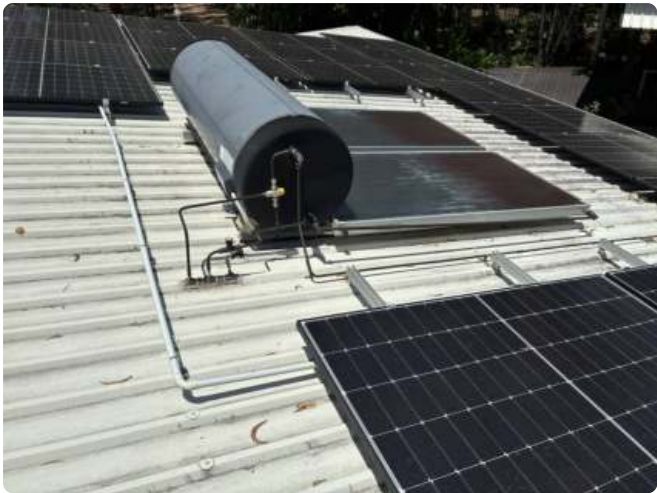
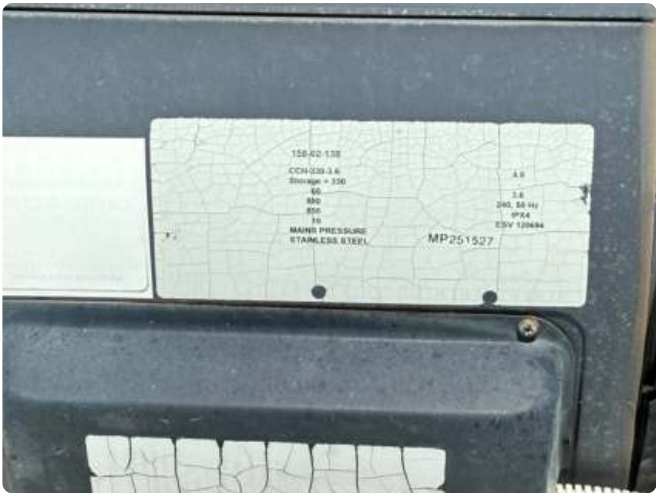
Hot Water System (Visual Only) - Continued

The hot water system appeared intact with no obvious visual defects at the time of inspection. No assessment was made regarding: temperature output, pressure relief valve operation, compliance with AS/NZS 3500, system age or remaining life, internal tank condition. This is not a performance or safety assessment. Pipework and insulation appeared visually consistent with typical residential installations. Sections that were concealed or obstructed could not be evaluated. No certification or operational testing was performed.

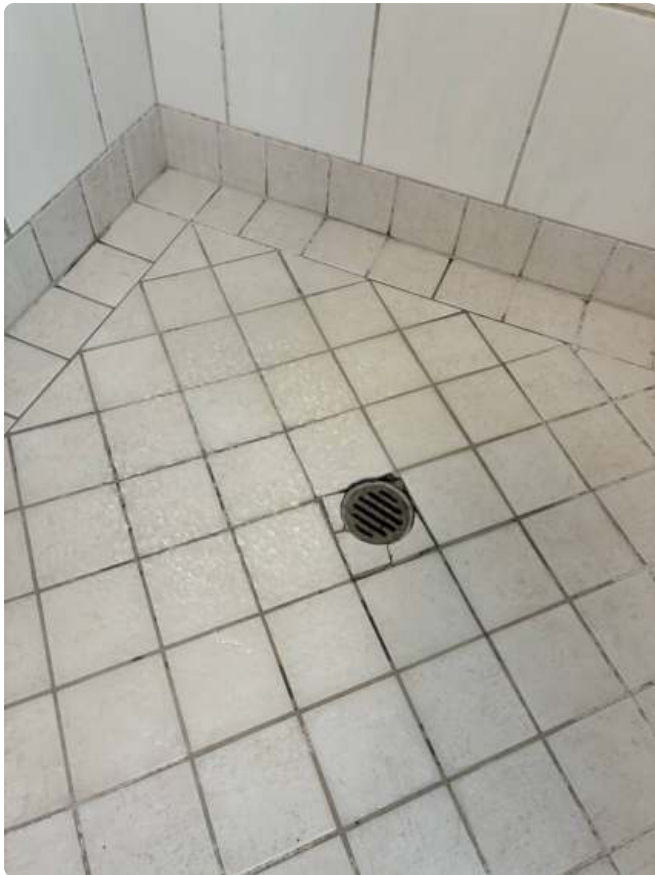
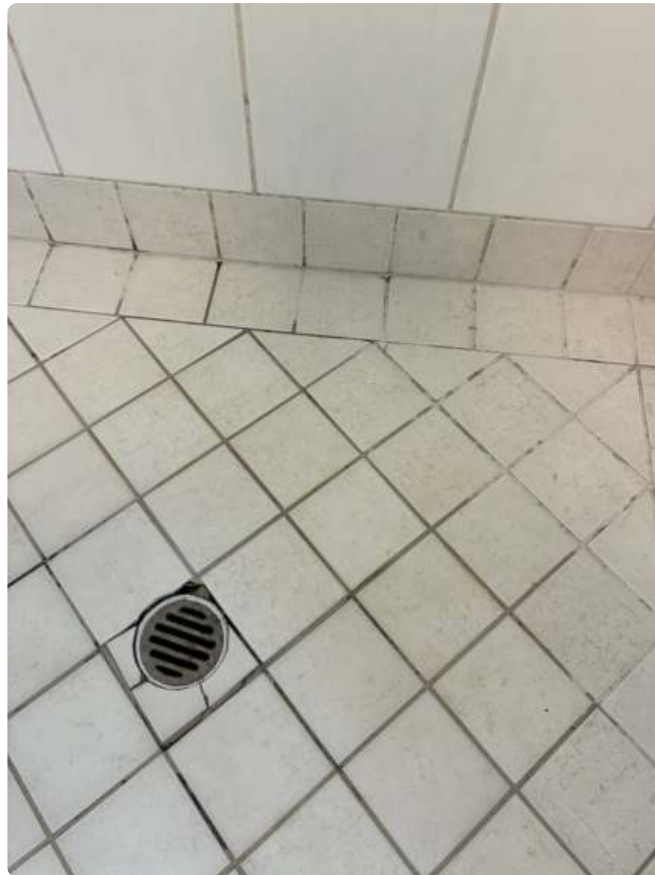
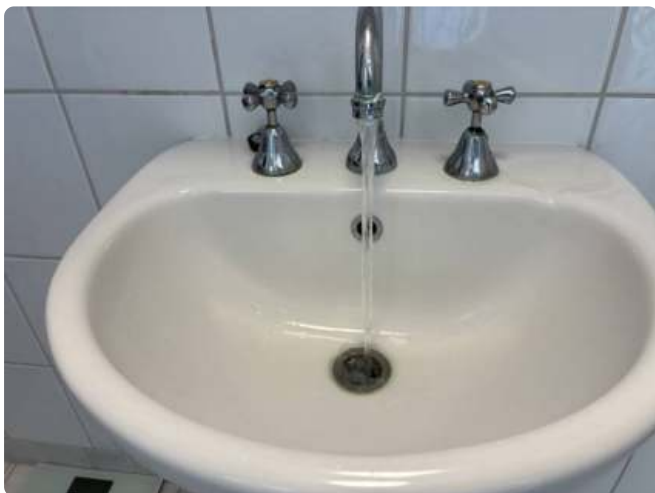
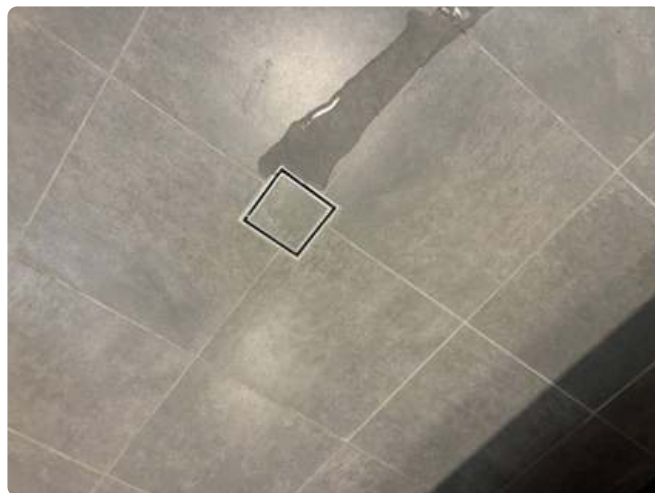
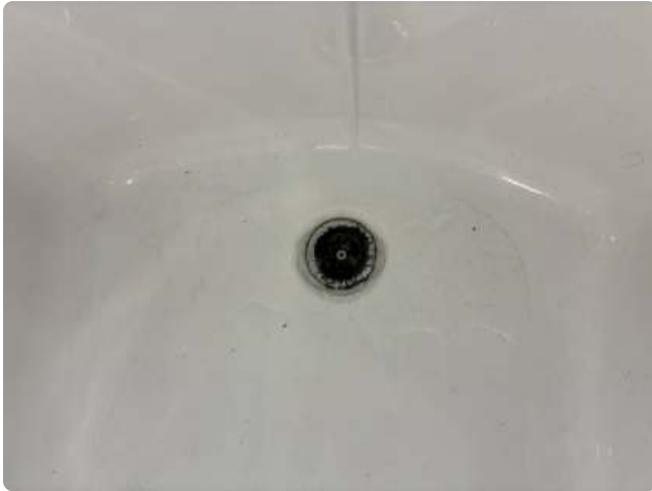
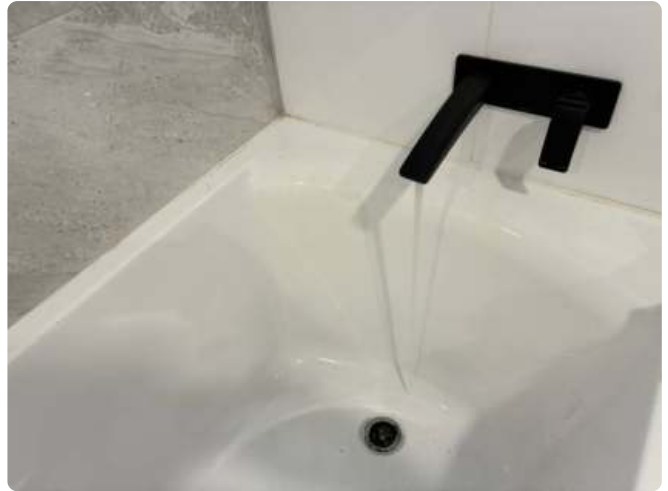
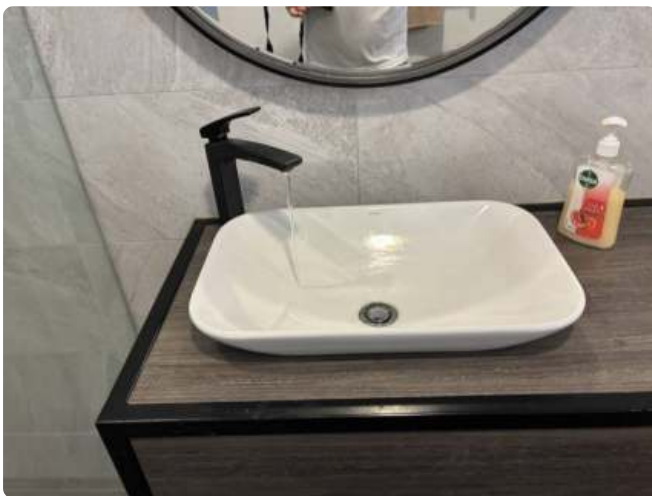
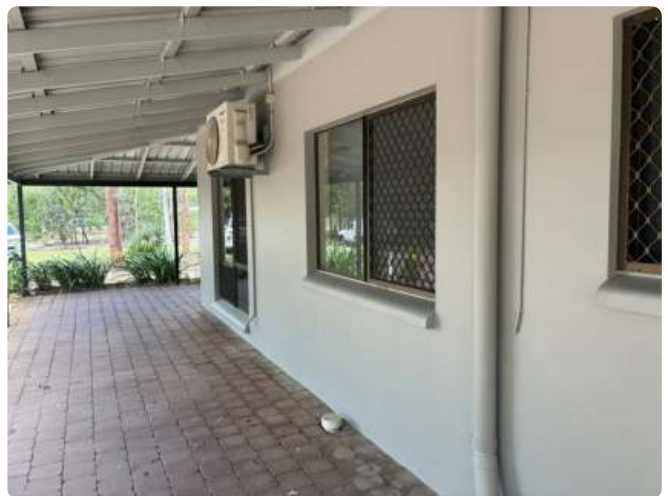
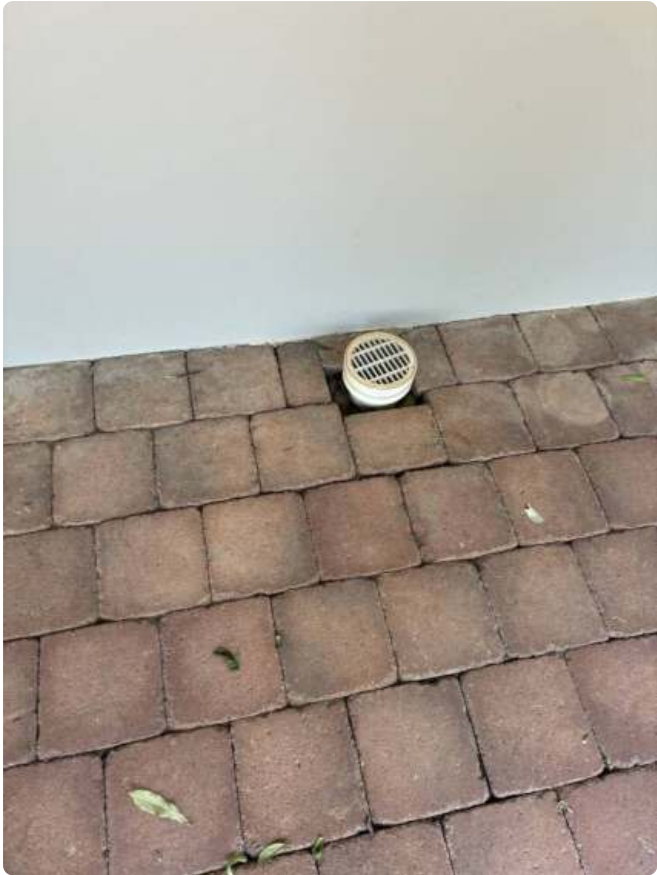
Surface water behavior in the ensuite indicated that water tracks toward cracked tiles. This may allow moisture entry into subsurface materials. Further evaluation by a licensed plumber or tiler is recommended. Other drainage points appeared unobstructed where visible. Limitations included: no access to subfloor drainage, no testing under load, no observation of internal pipe condition.

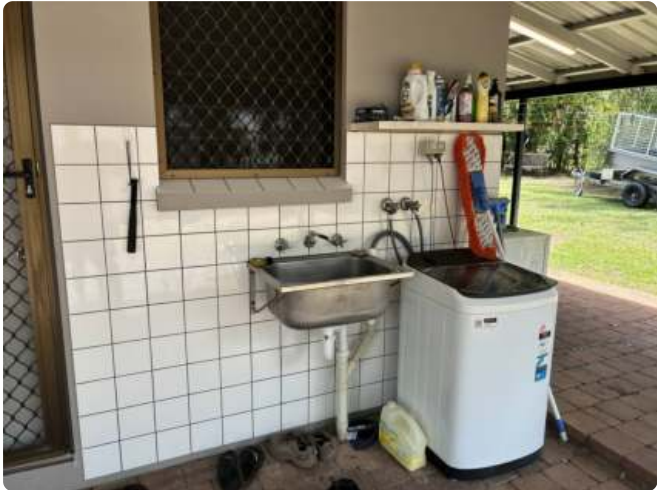
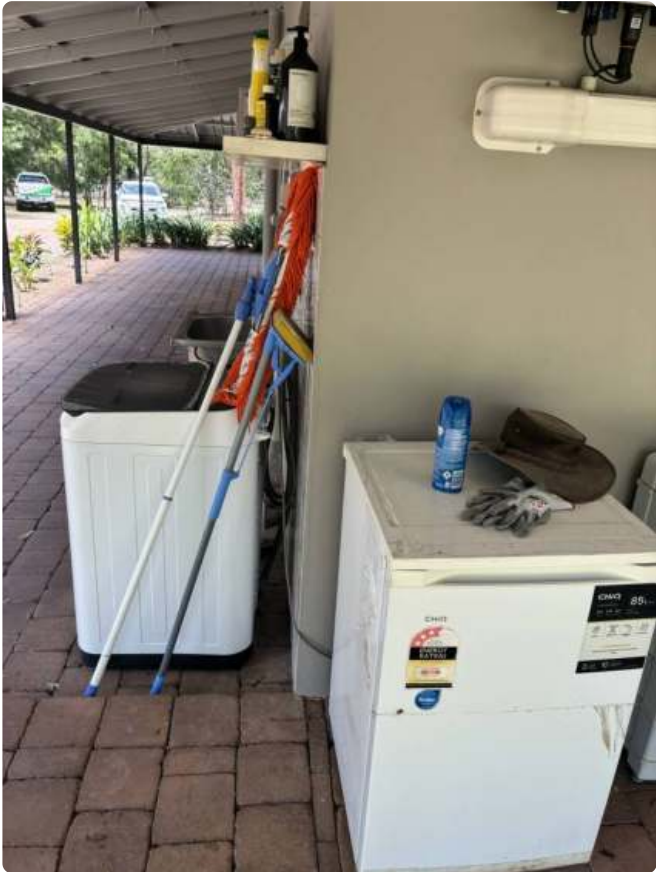
Laundry - Continued

Laundry plumbing appeared intact in visible areas. No performance testing of taps, traps, or drainage was undertaken. No concealed areas were assessed. No active leaks were visible at the time of inspection. Some fixtures displayed minor cosmetic wear consistent with age. Hidden deterioration cannot be assessed without invasive testing.
