# **BUILDING INSPECTION & CONDITION REPORT**

12 Brumby Court, Marlow Lagoon NT 0830

25th November, 2025

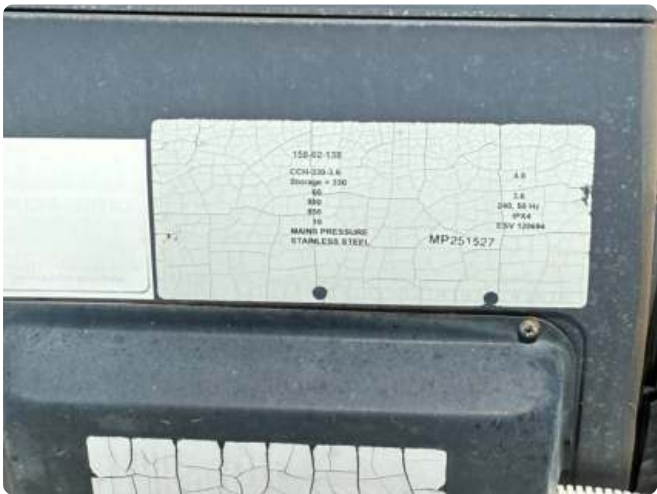
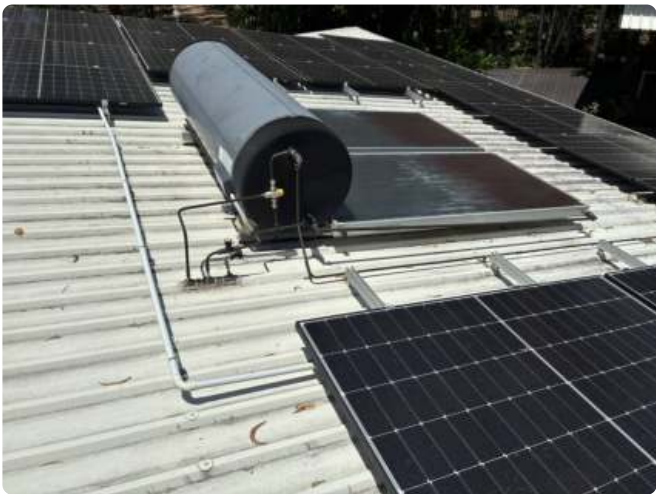
| Condition | Good Condition |
| Type of Hot Water System | Solar |
| Location of Hot Water Unit | Roof |

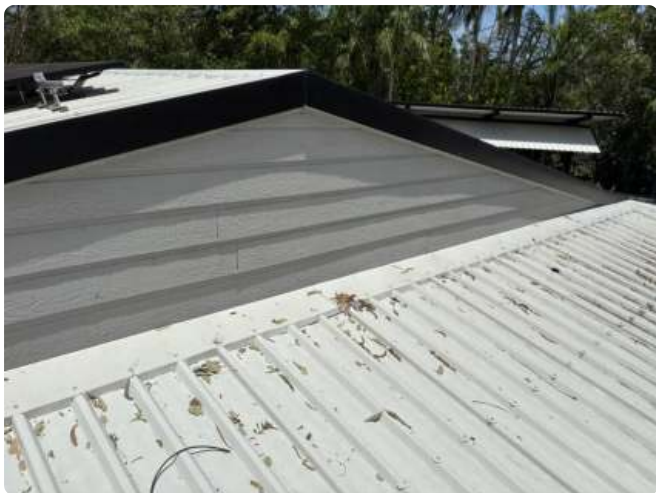
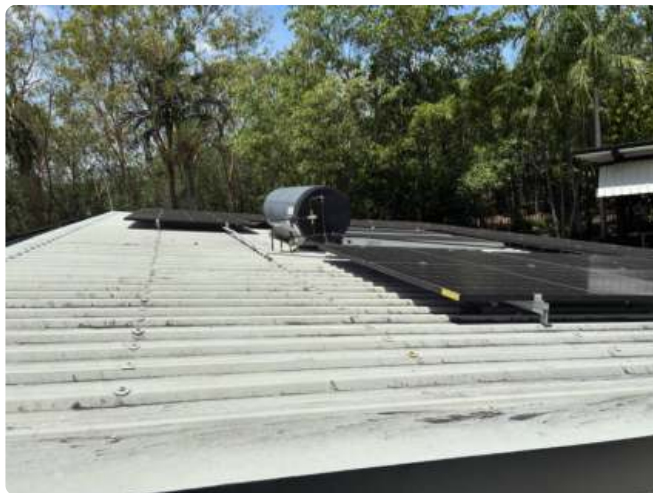
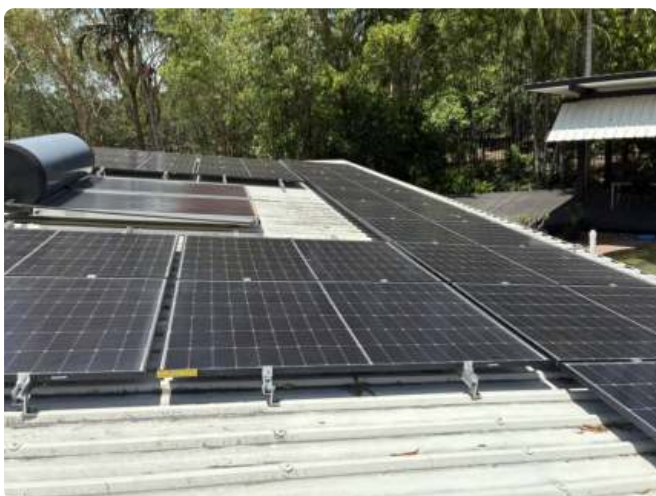
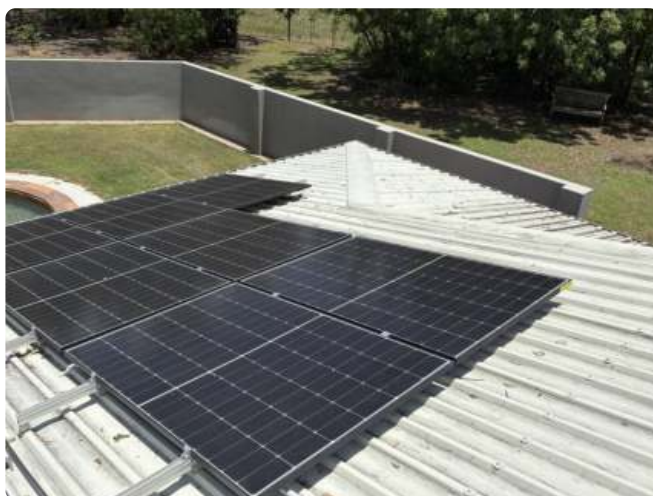
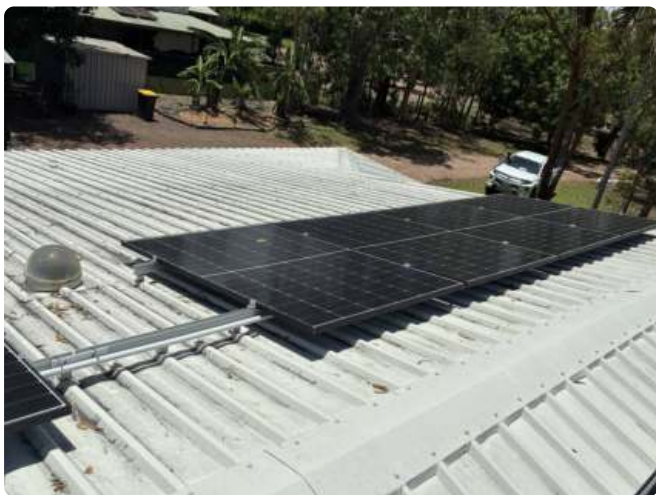
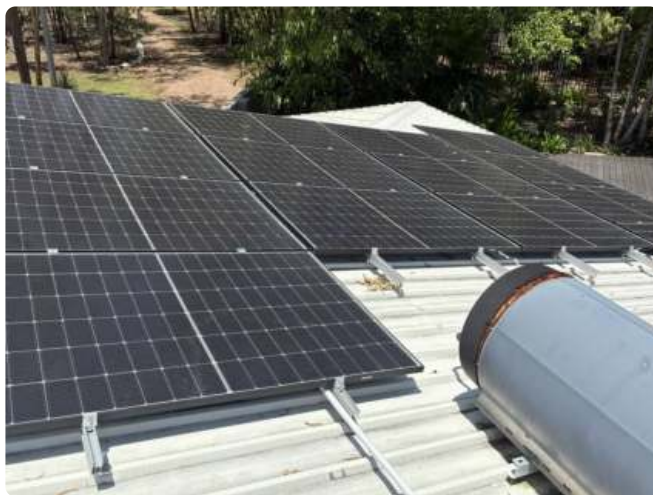
| Inspector Notes | <p>The roof exterior was viewed from roof level, allowing closer visual access to accessible surfaces. No obvious defects were visible within the areas inspected at the time of the assessment; however, this observation remains limited to what could be safely reached and seen without removing roof materials or conducting invasive investigation. This visual inspection does not confirm: • structural adequacy, • waterproofing performance, • compliance with NCC/BCA roofing standards, • condition of concealed fixings, battens, or underlayments, • future weather performance. Areas obstructed by pitch, roofing geometry, debris, or safety considerations could not be inspected, and concealed deterioration may exist outside the visible areas.</p> |

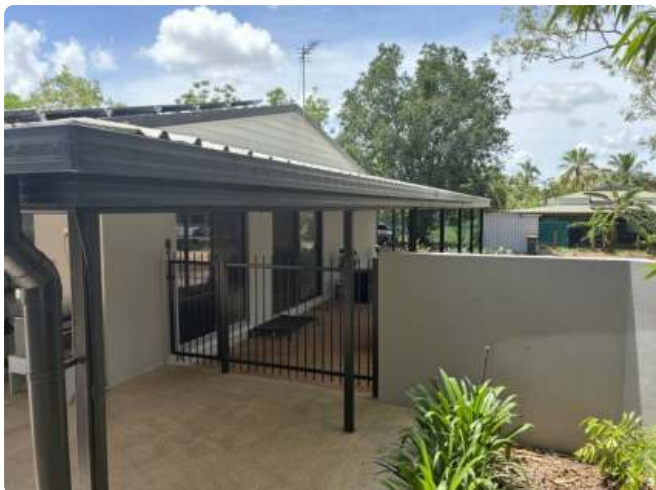
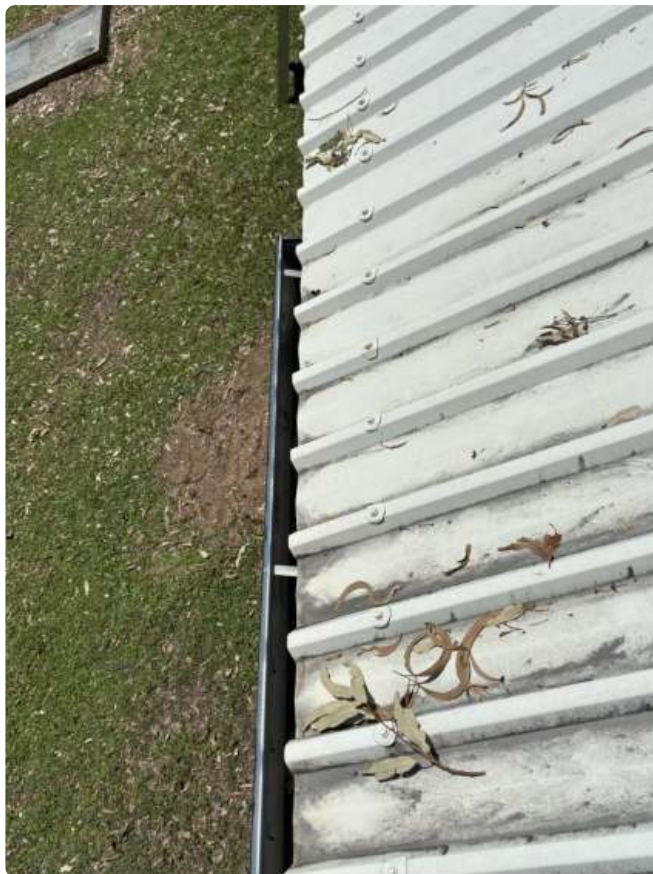
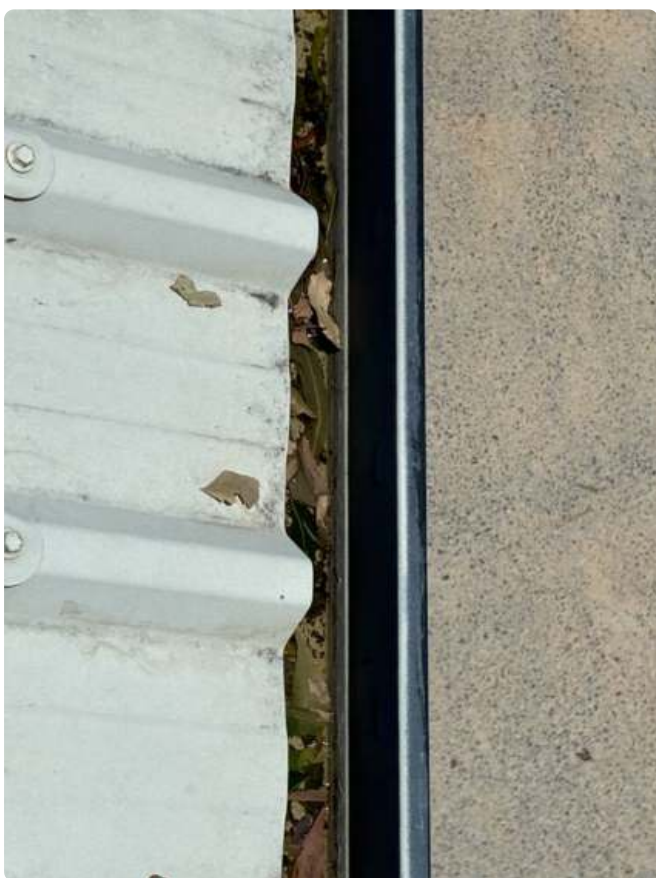
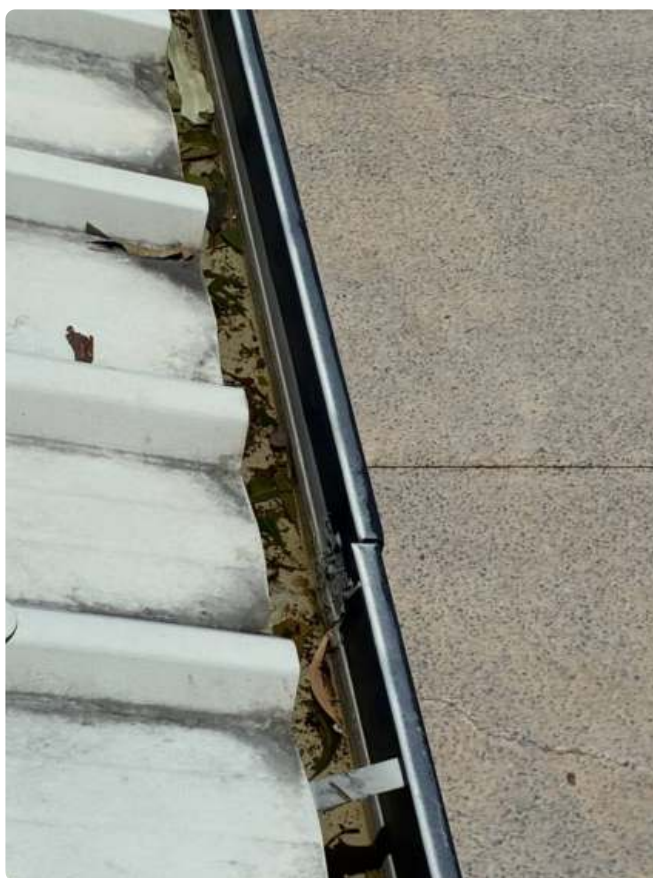
| Inspector Notes | Eaves and gutters appeared functional at the time of limited visual inspection. No obvious deterioration was visible from roof and ground-level viewing. Gutters exhibited visible debris accumulation restricting drainage. Clearing of debris is recommended to maintain effective water flow. |

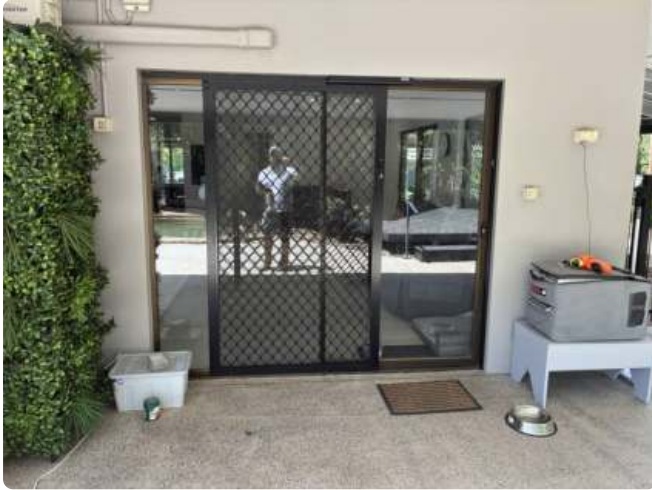
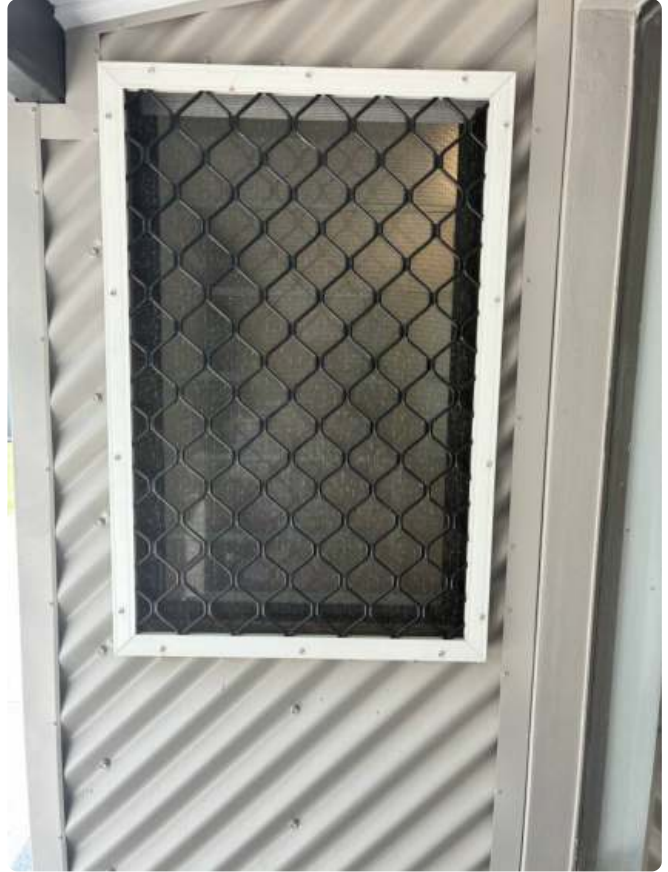
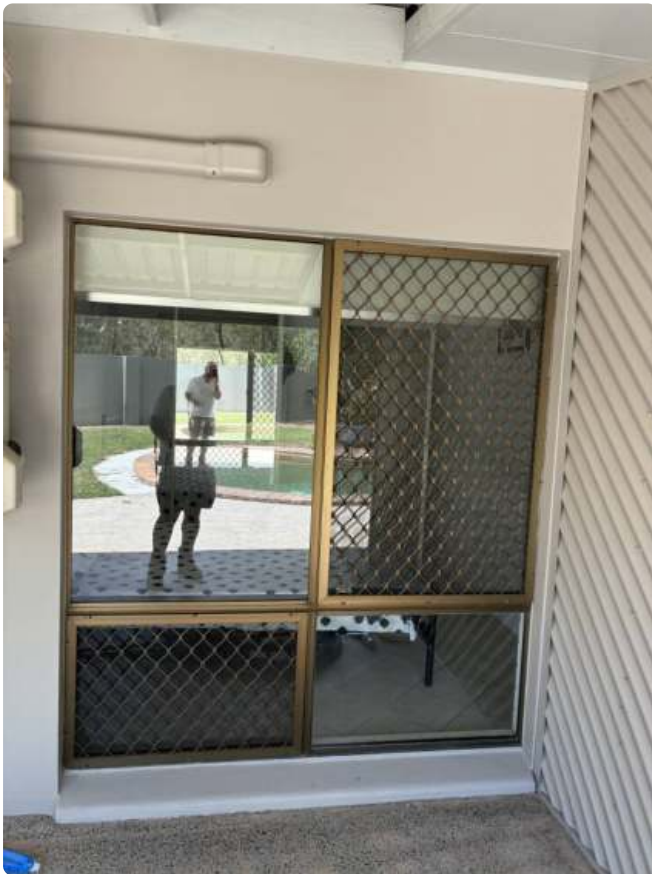
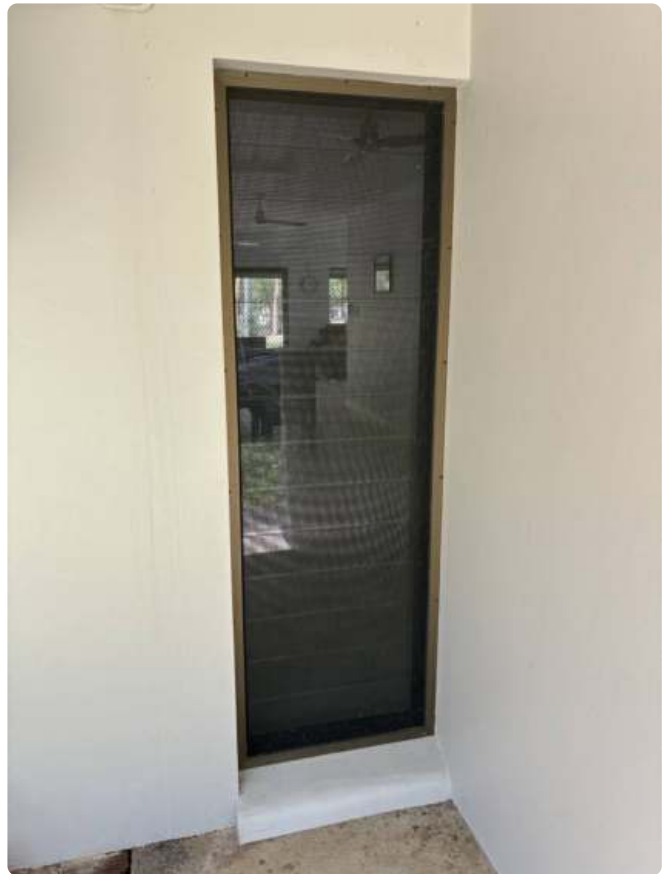
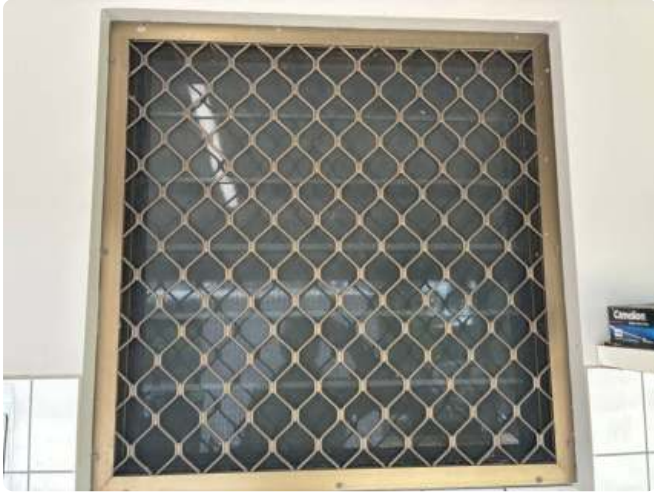
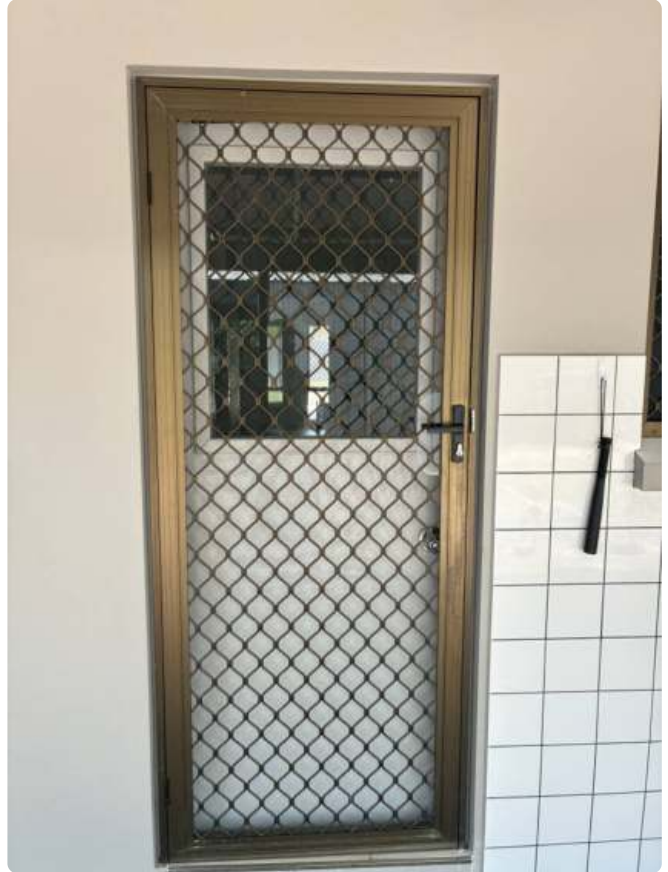
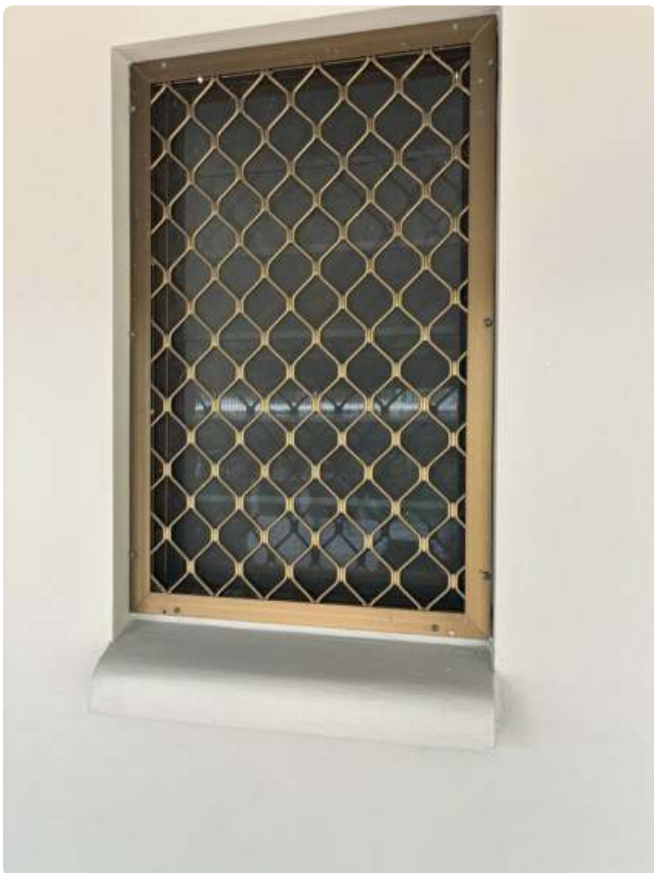
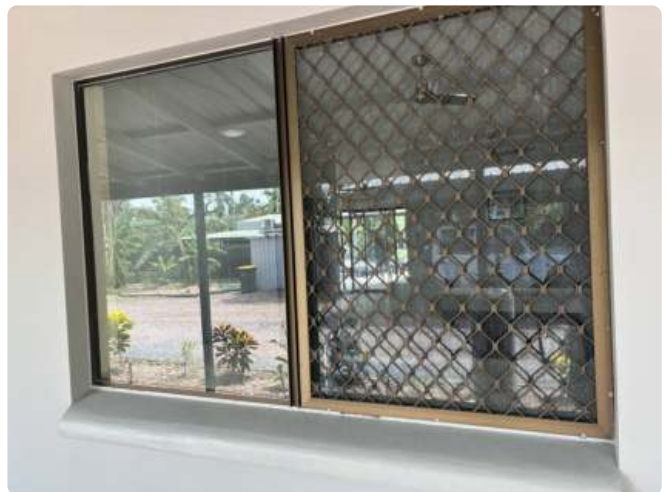
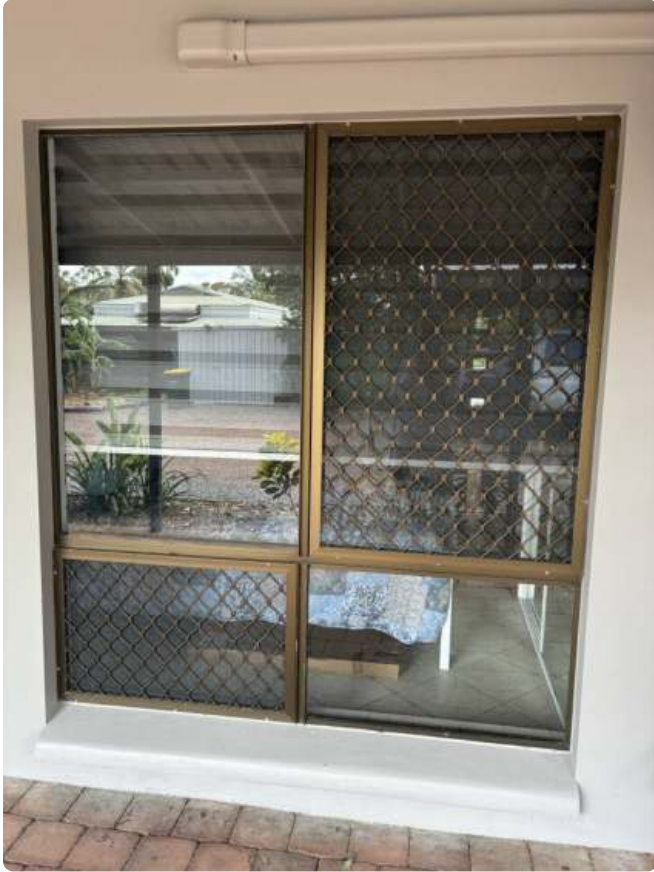
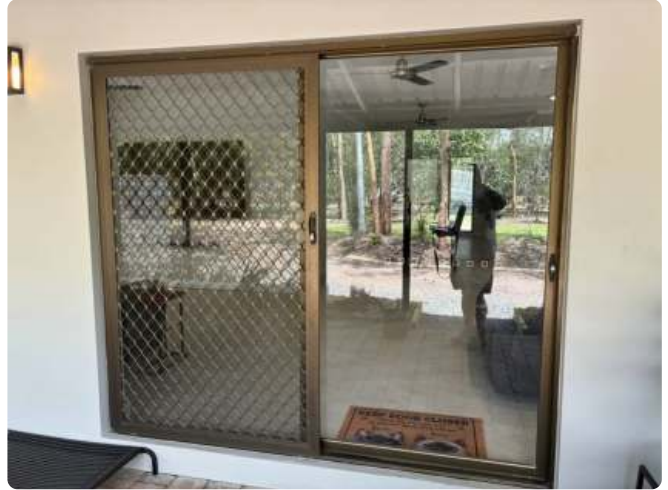
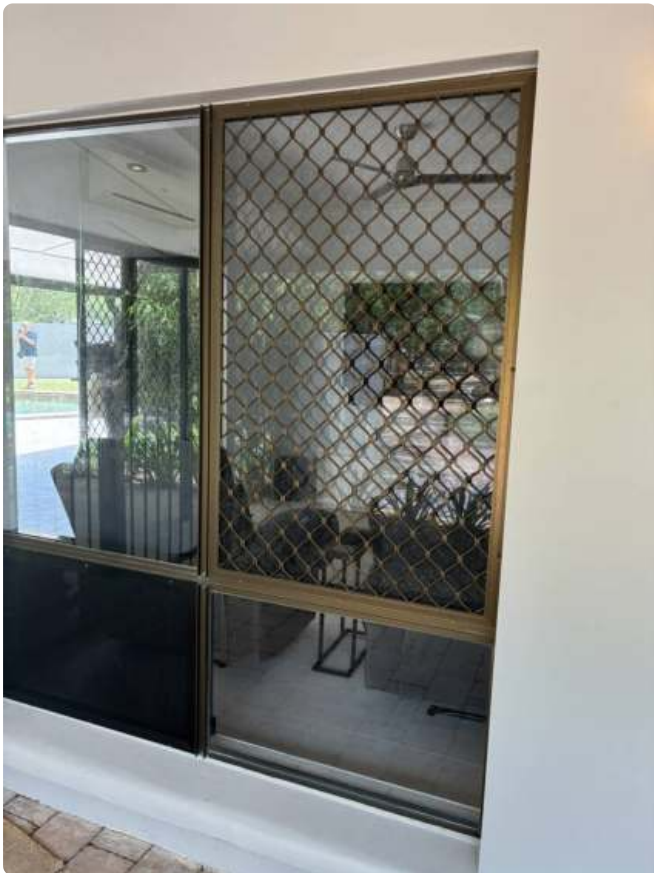
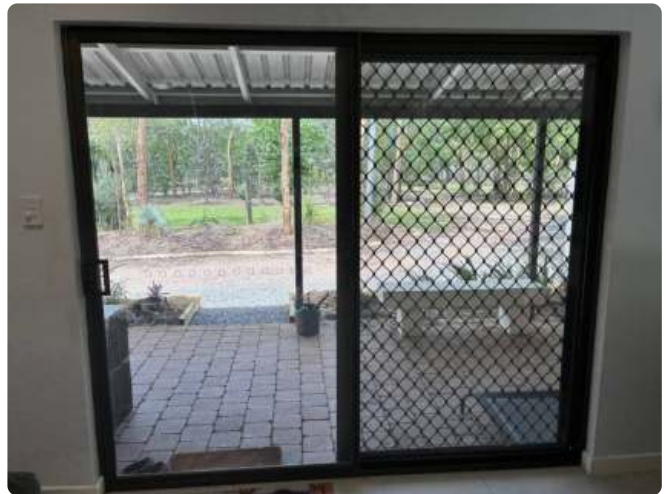
Windows & Doors (External)

| Condition | Minor Defect |
| Inspector Notes | Windows and doors appeared functional at the time of inspection. Minor wear was visible to seals and frames. Operation was assessed only by basic opening and closing where accessible; no performance, weather-tightness, or compliance testing was conducted. |

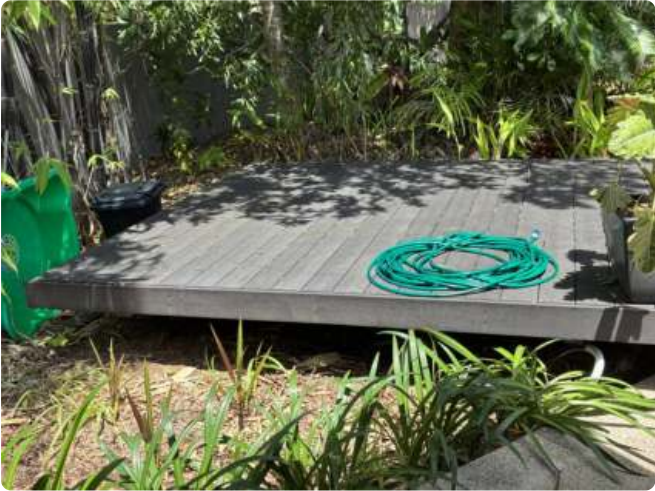
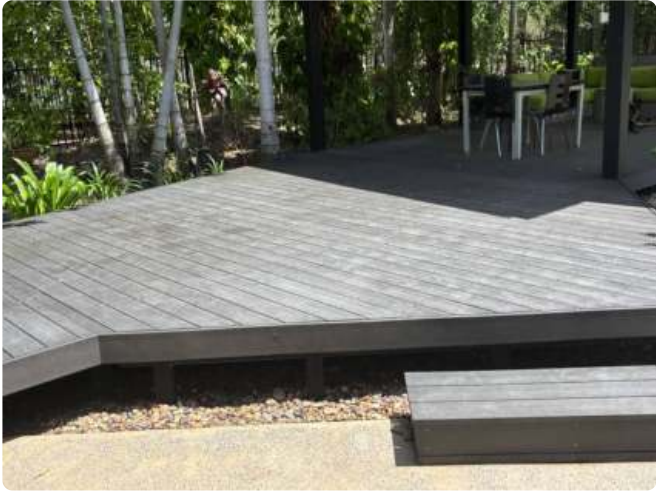
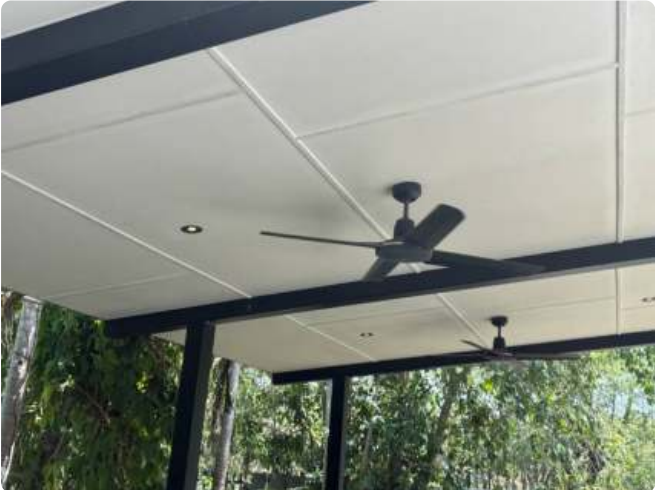
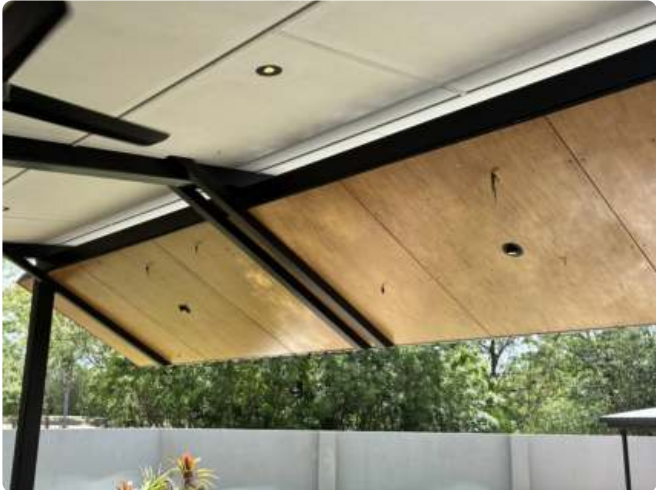
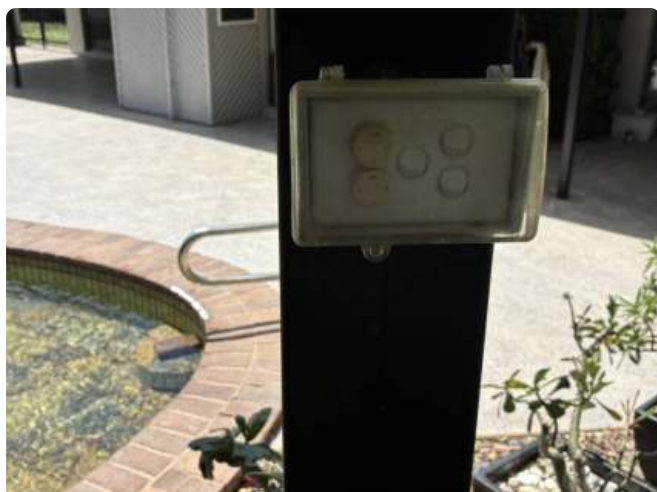
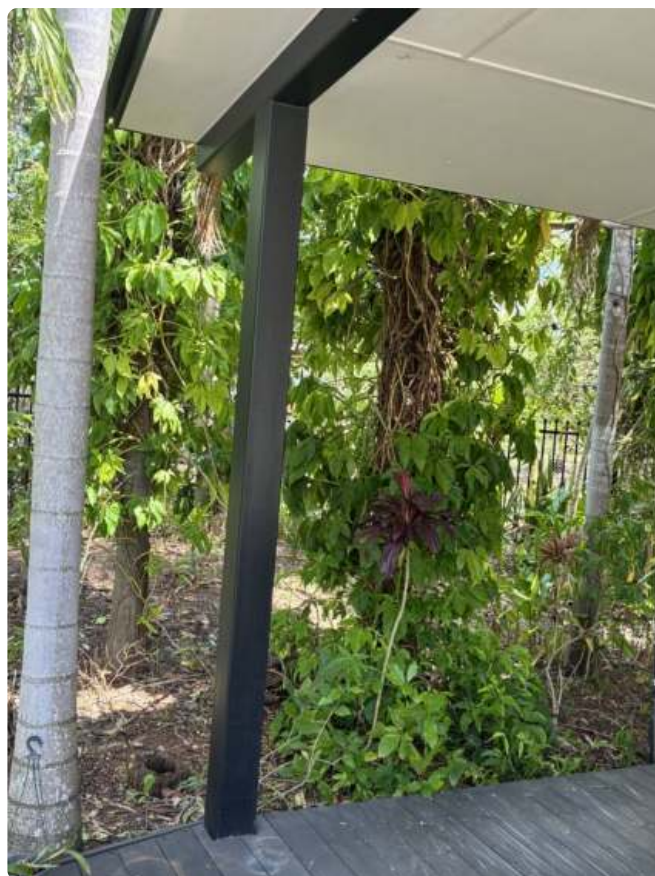
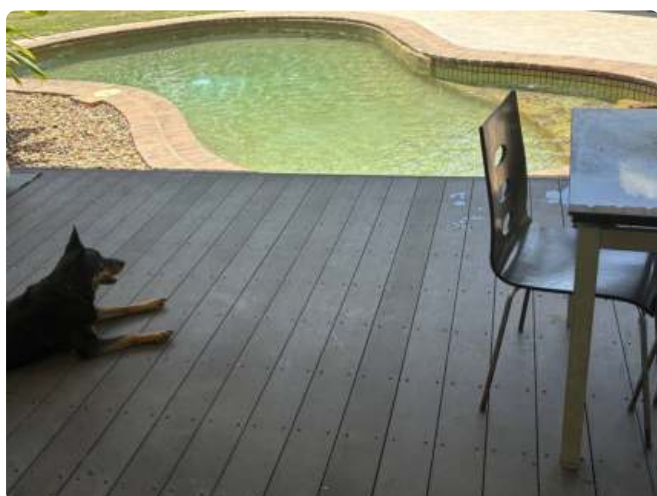
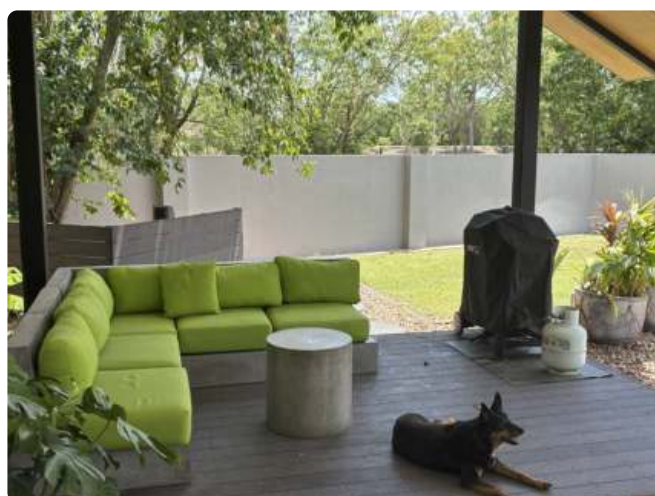
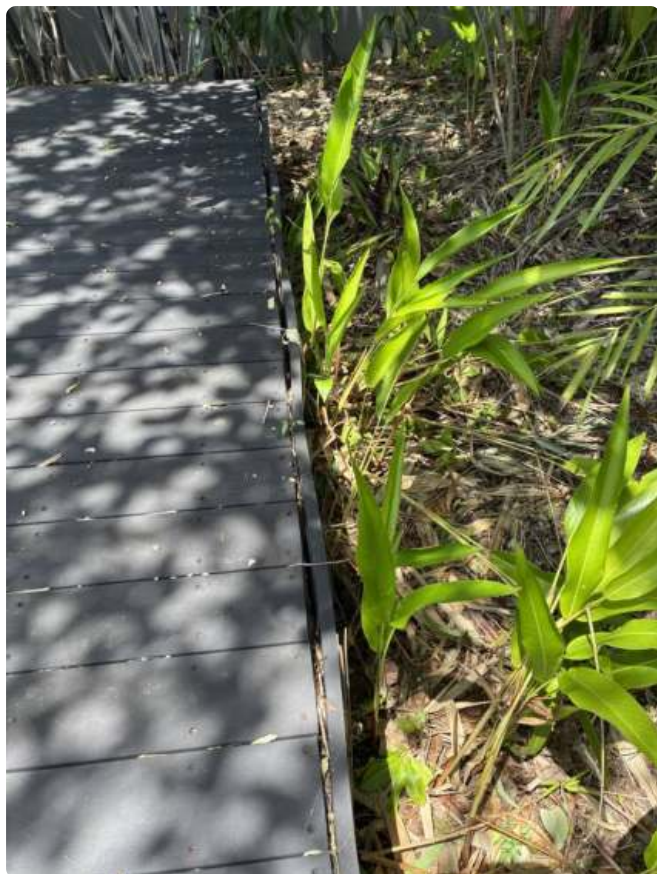
| Deck/Verandah | |
|---|---|
| Condition | Minor Defect |
| Inspector Notes | Deck and verandah appeared functional at the time of inspection. Eco-board sections were visibly peeling. Further deterioration is possible if left unaddressed. |

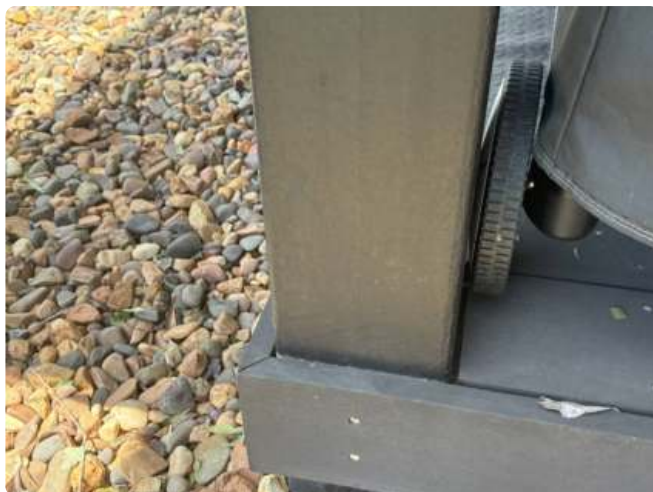
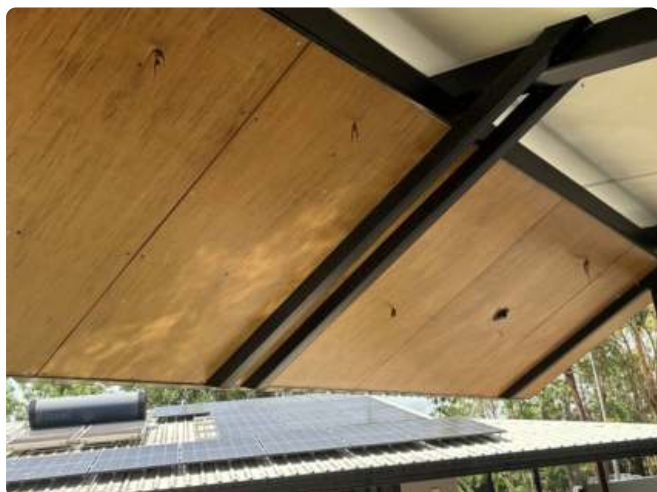
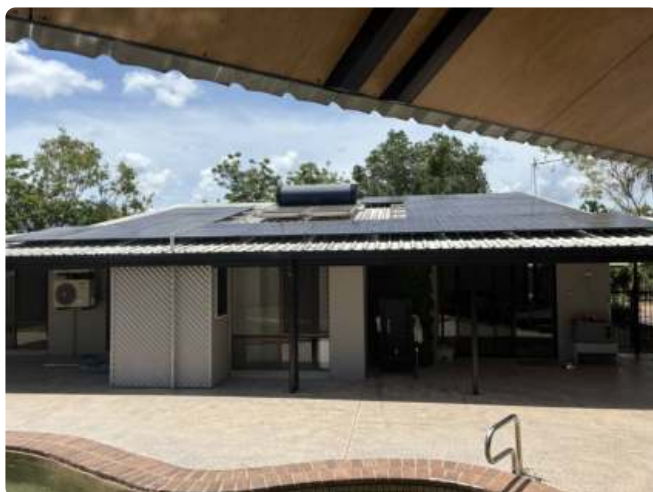
Decking boarder is bowing and peeling away from subframe.

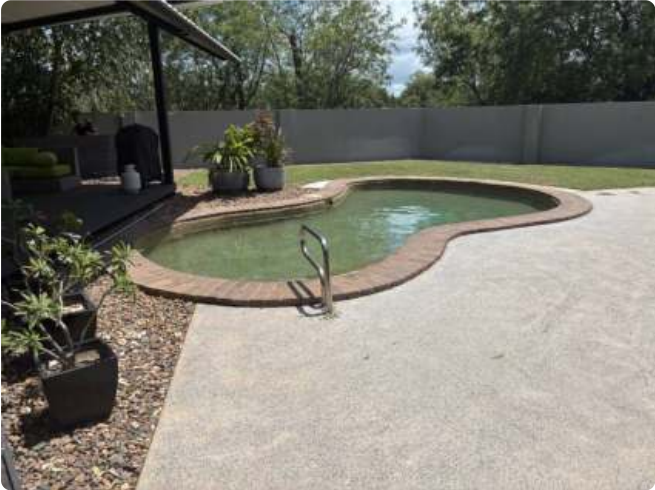
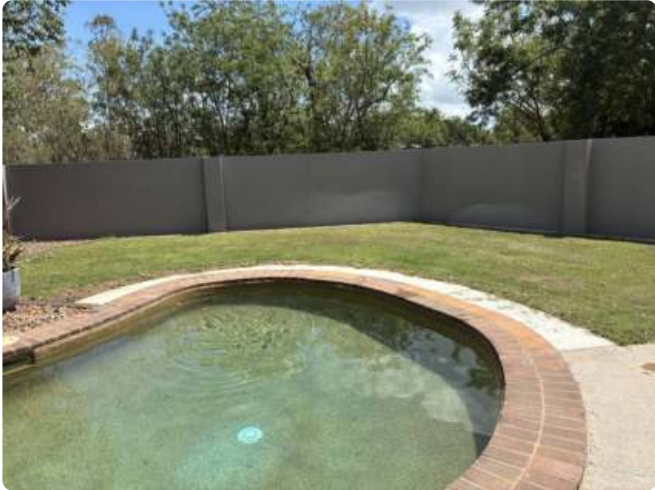
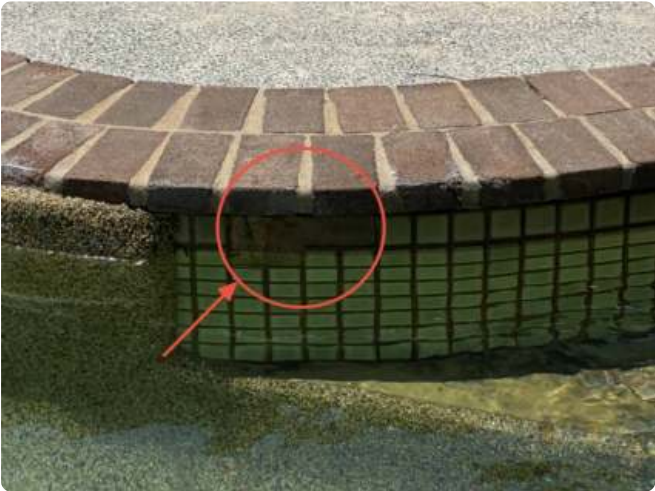
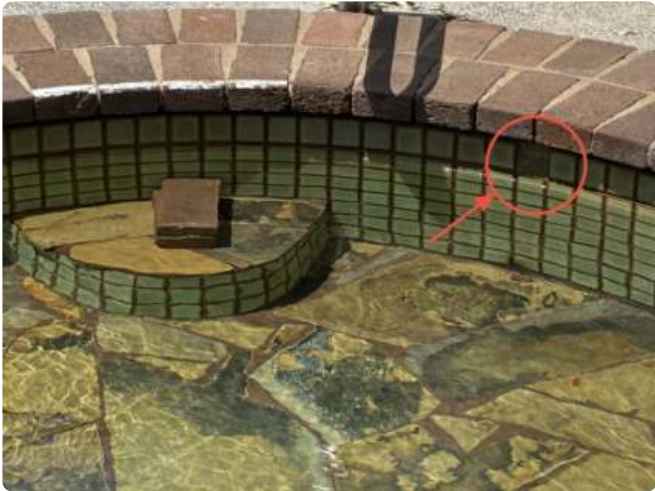
Pool structure appeared functional at the time of inspection. Several tiles were observed detaching near the steps. No assessment of pool fencing, compliance, depths, bonding, electrical components, or filtration systems was performed.

| Pool/Spa - Continued | |
|---|---|
| <div> <div>Tiles missing inside pool structure</div> <div>Tiles missing inside pool structure</div> </div> | |

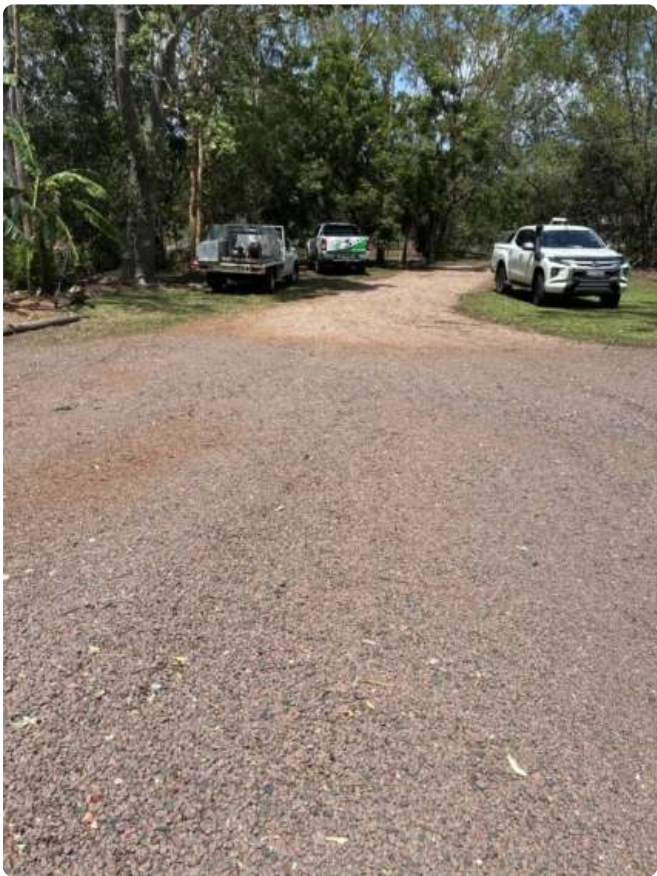
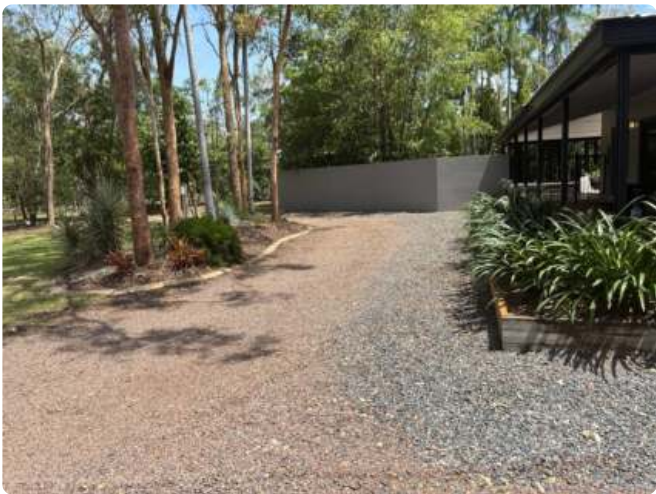
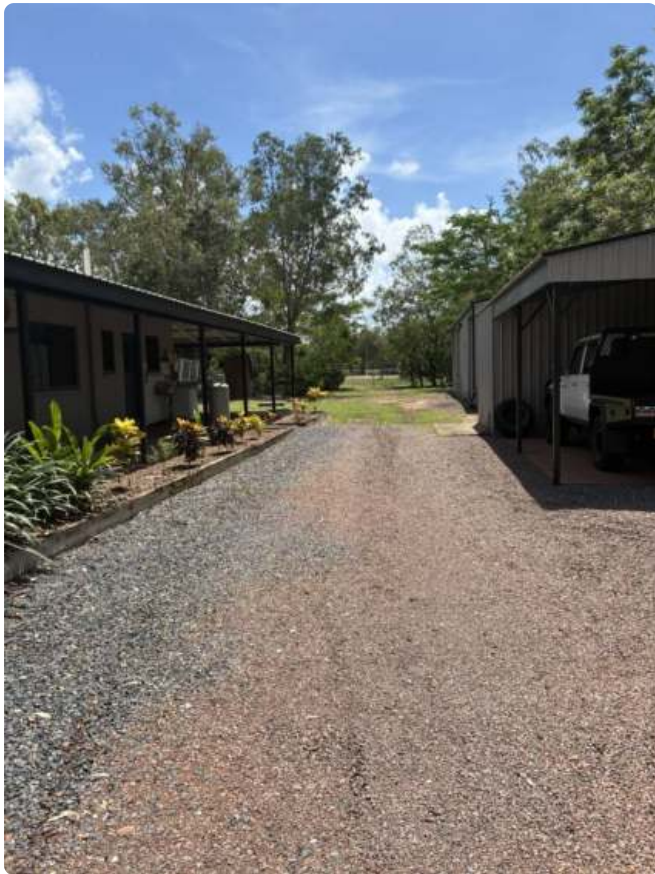
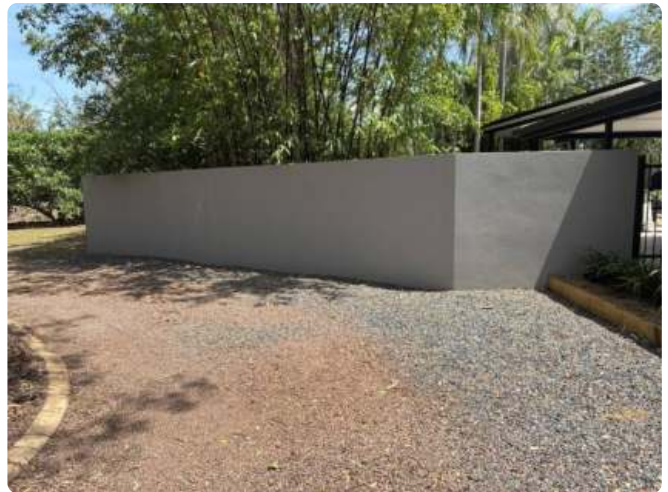
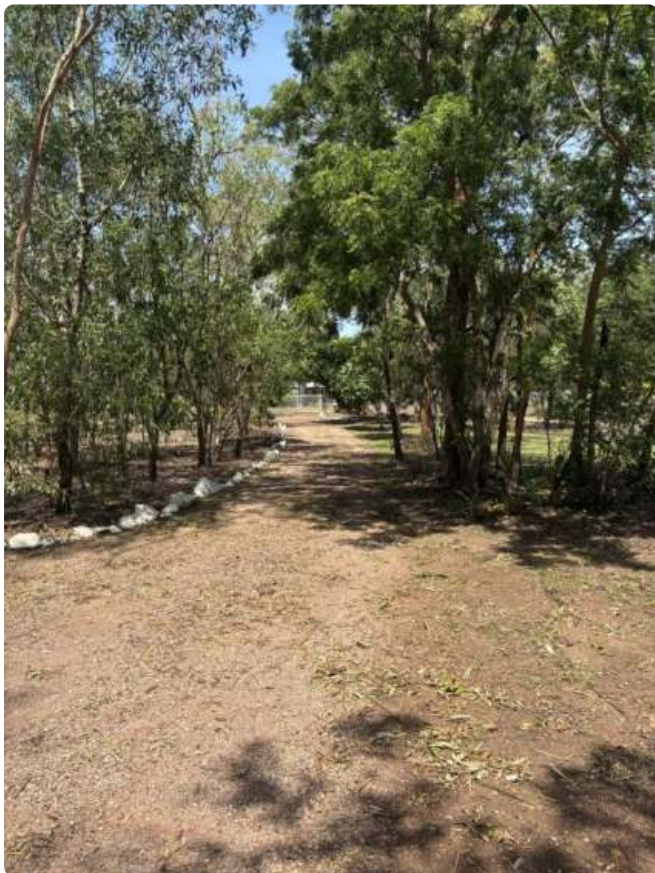
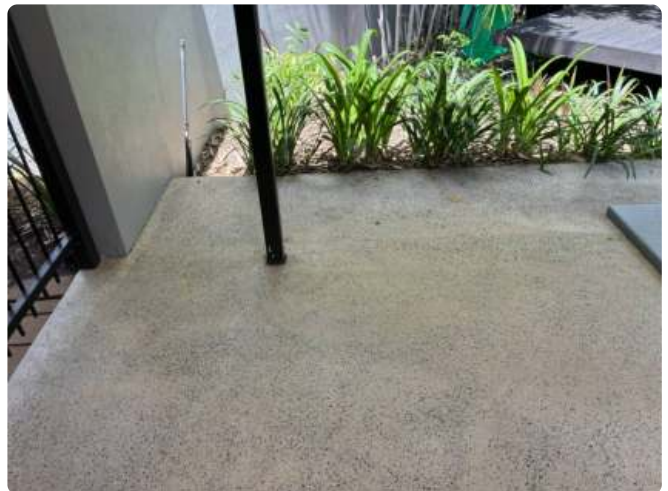
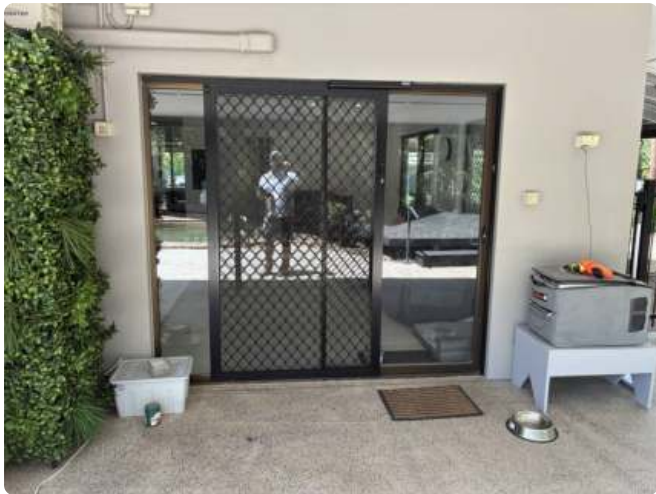
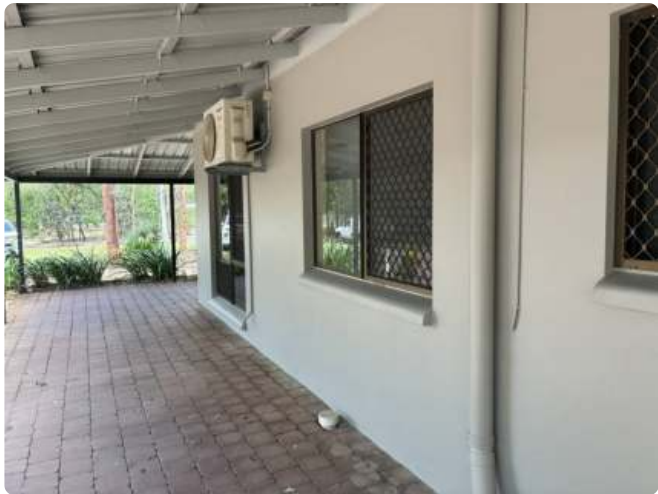
Driveways/Paths

Gravel, concrete, paved surfaces exhibited typical wear. Minor staining was visible. No obvious trip hazards were visible within accessible areas. These observations do not confirm compliance with gradient or slip-resistance requirements.

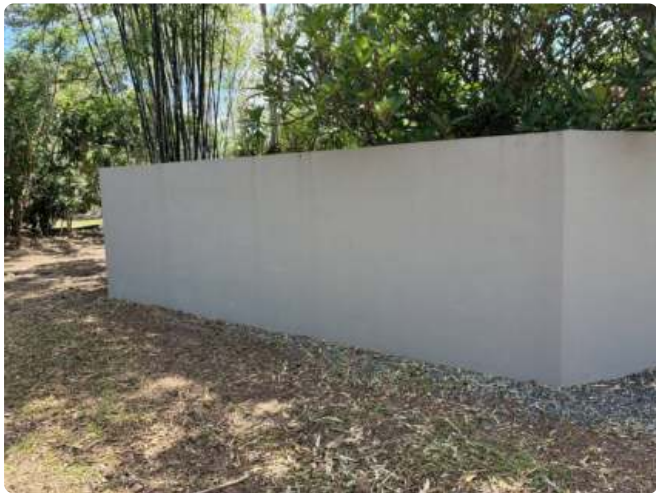
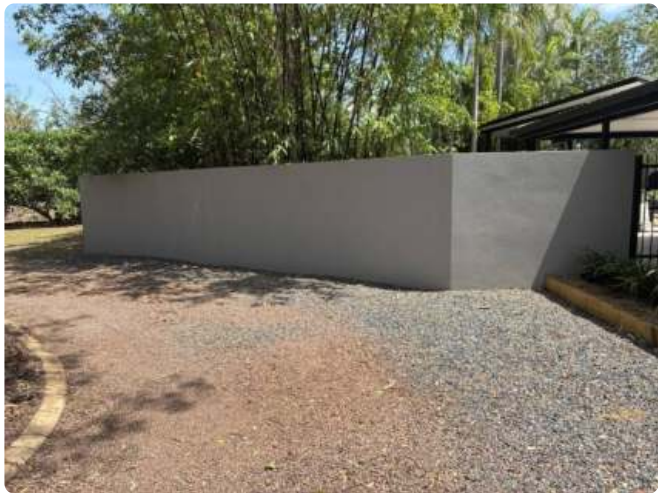
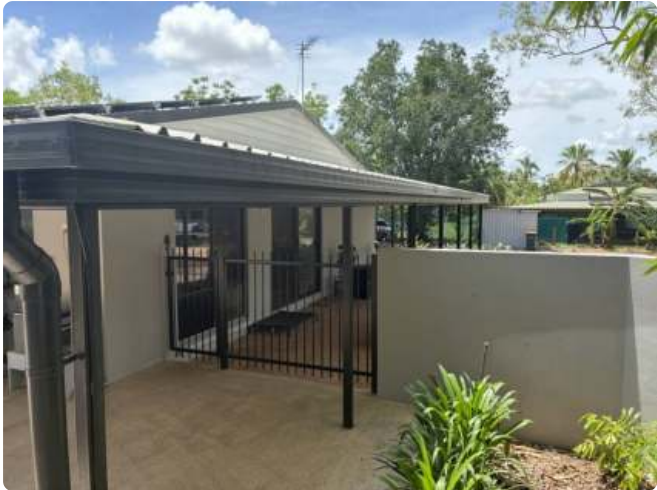
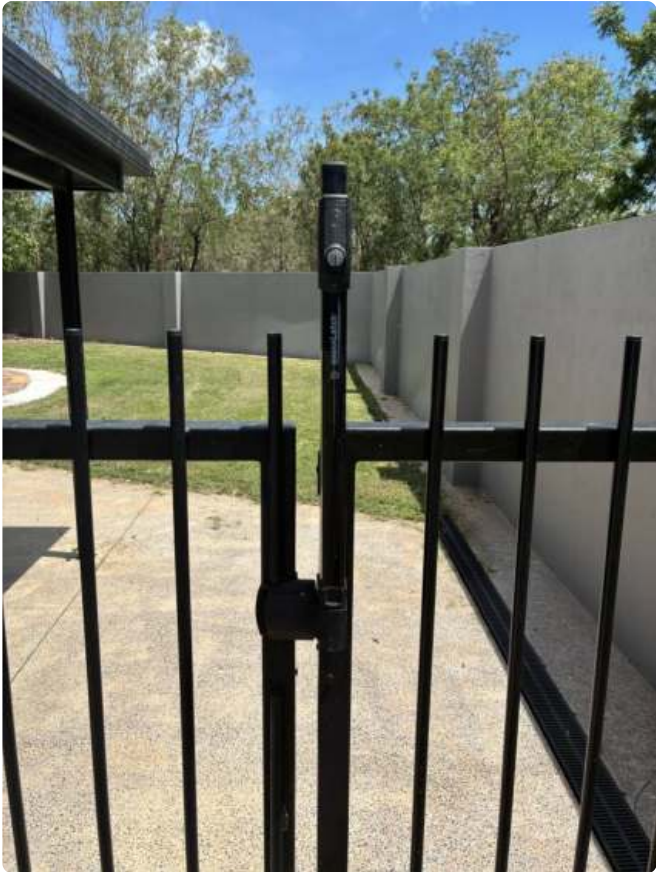
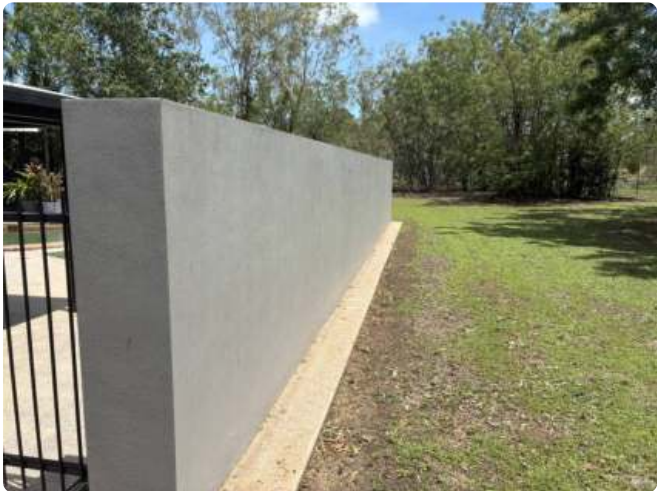
Retaining Walls

Retaining wall surfaces appeared functional at the time of limited visual inspection. Minor cosmetic deterioration was visible. No obvious cracking was visible; however, concealed movement cannot be assessed without invasive investigation.
