# **BUILDING INSPECTION & CONDITION REPORT**

12 Brumby Court, Marlow Lagoon NT 0830

25th November, 2025

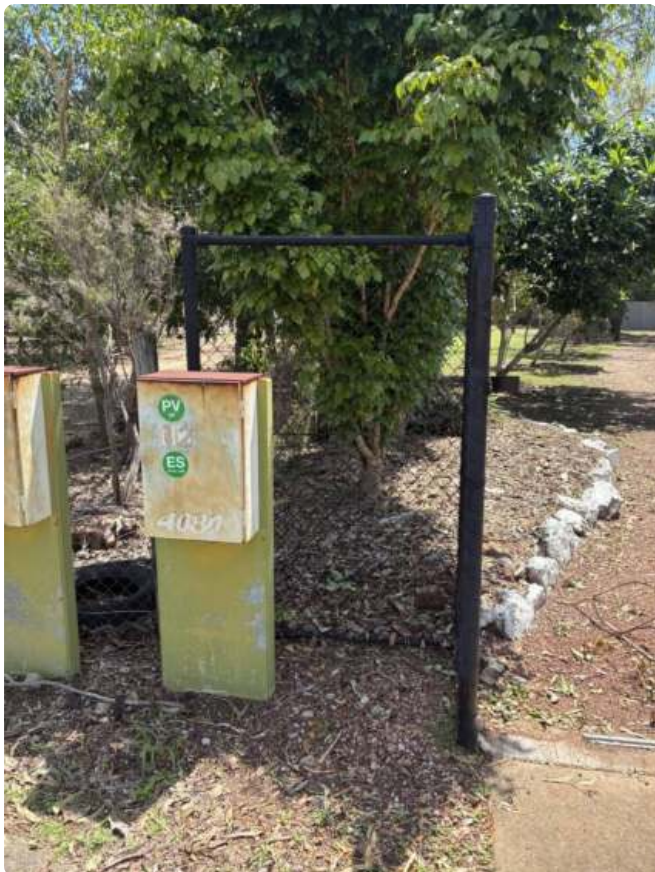
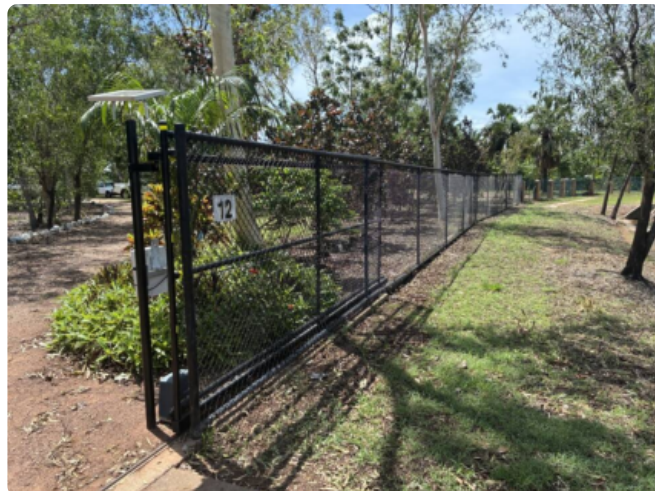
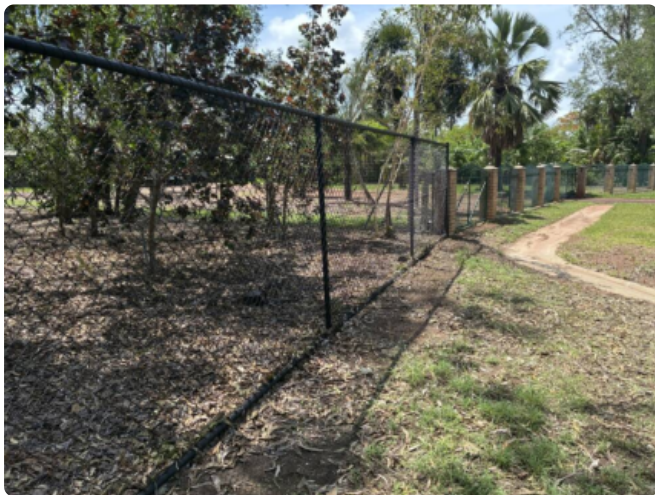
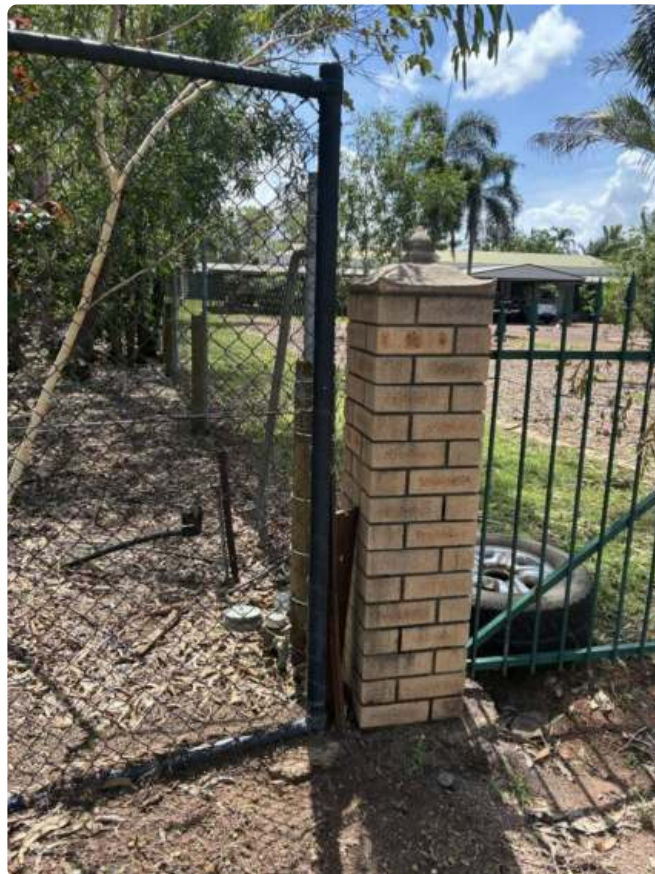
Boundary Fencing

Boundary fencing and gates appeared serviceable at the time of inspection. Minor surface rust and general wear were visible. No structural concerns were observed in accessible areas.

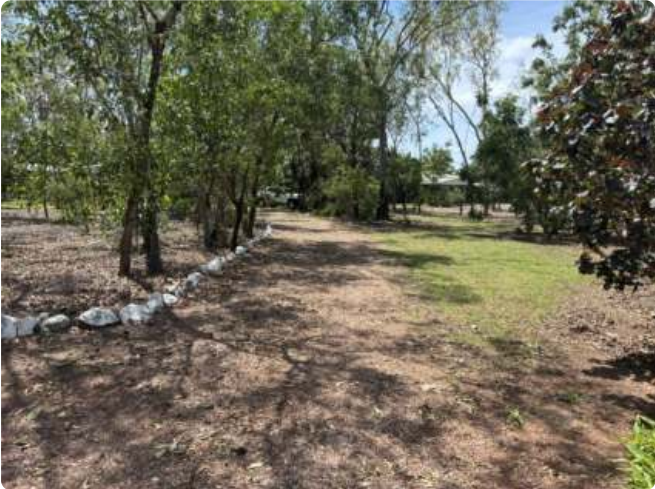
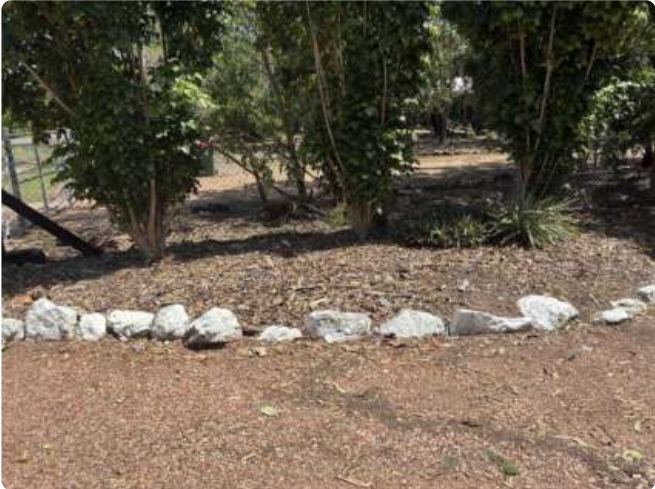
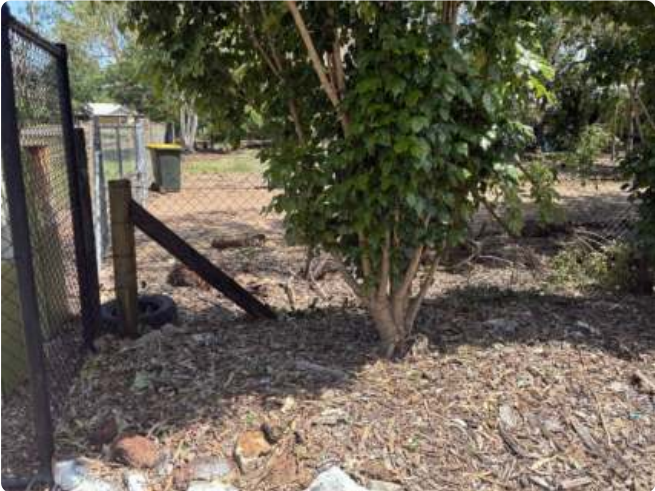
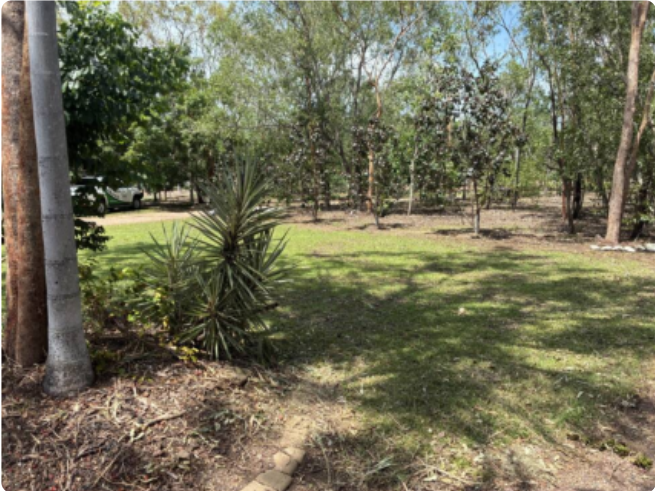
| Inspector Notes | Gardens appeared functional at the time of limited visual inspection, with debris present due to recent weather. No obvious site drainage issues were visible; however, surface-only observations cannot confirm sub-surface conditions. |

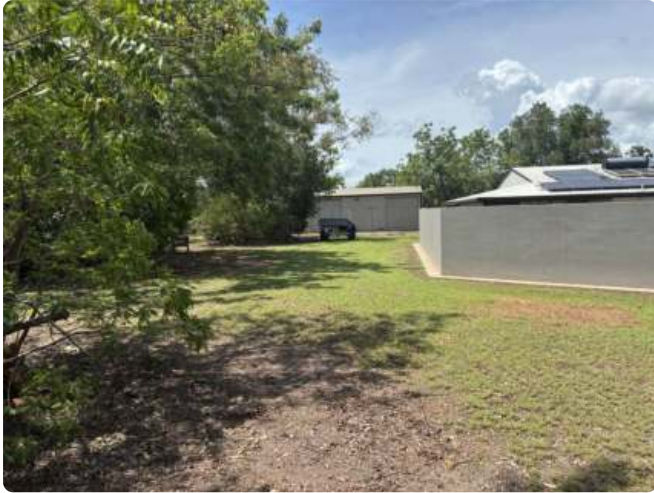
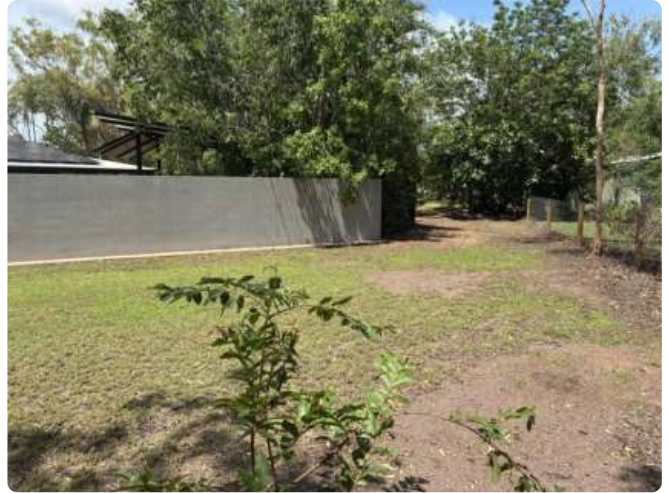
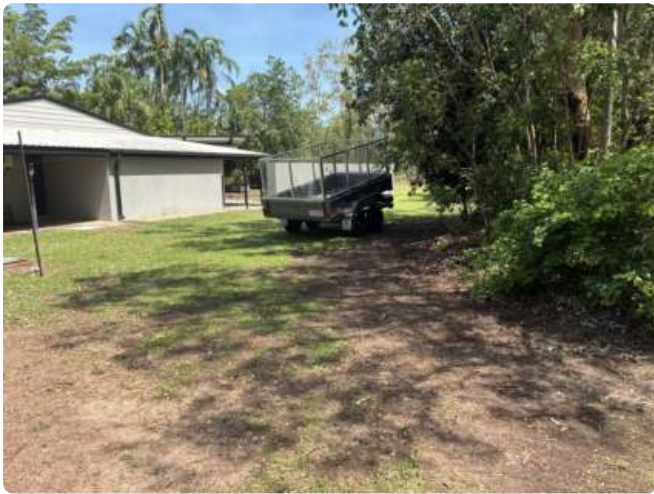
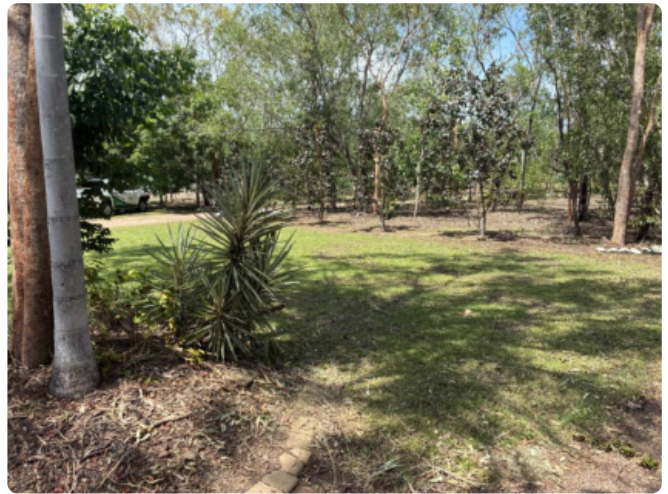
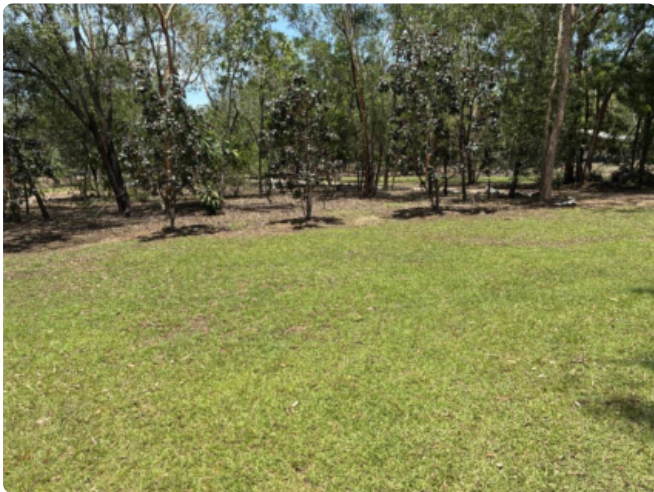
## Lawns - Continued

Lawns appeared functional at the time of limited visual inspection, with debris present due to recent weather. No obvious site drainage issues were visible; however, surface-only observations cannot confirm sub-surface conditions.

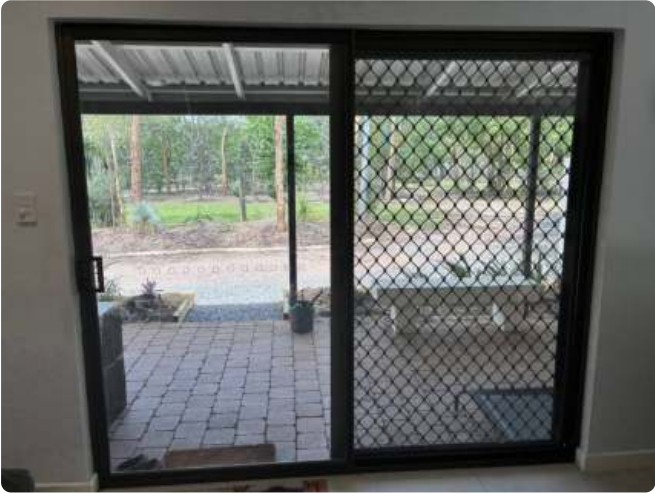
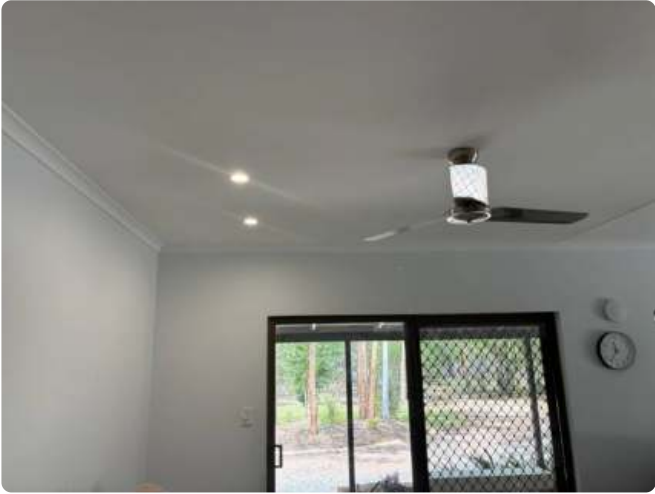
| Inspector Notes | Entry area displayed minor cosmetic wear. No obvious structural concerns visible. |

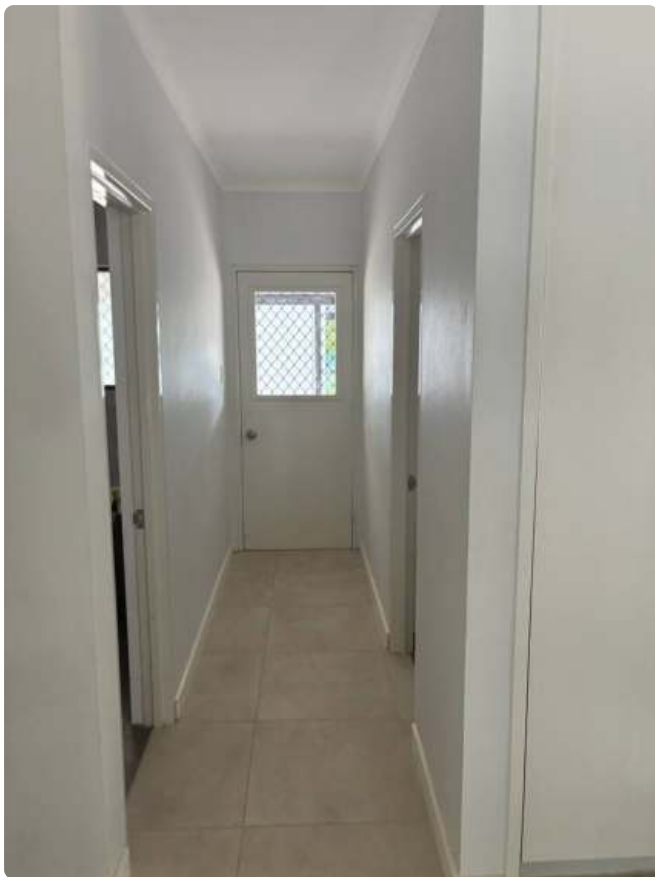
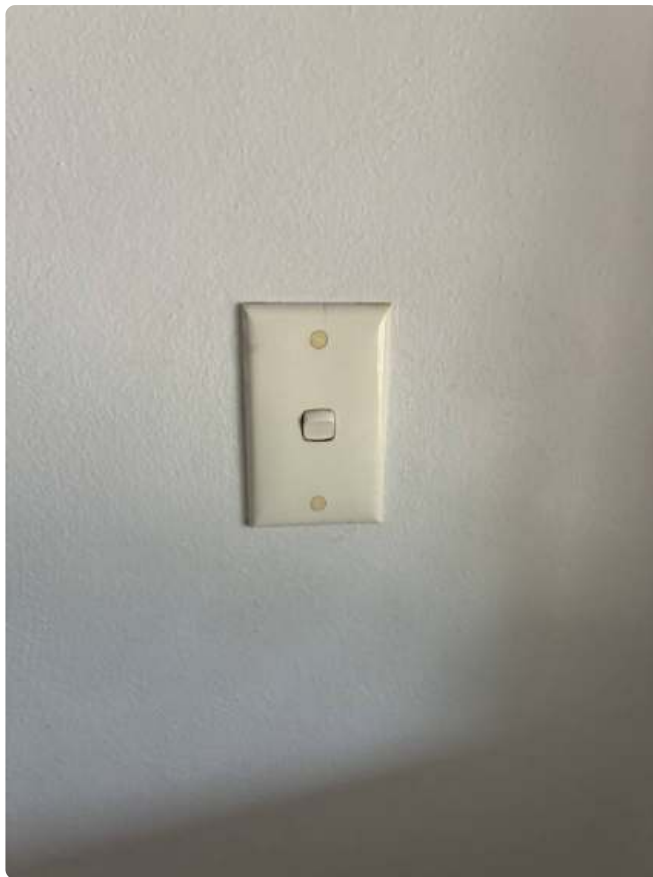
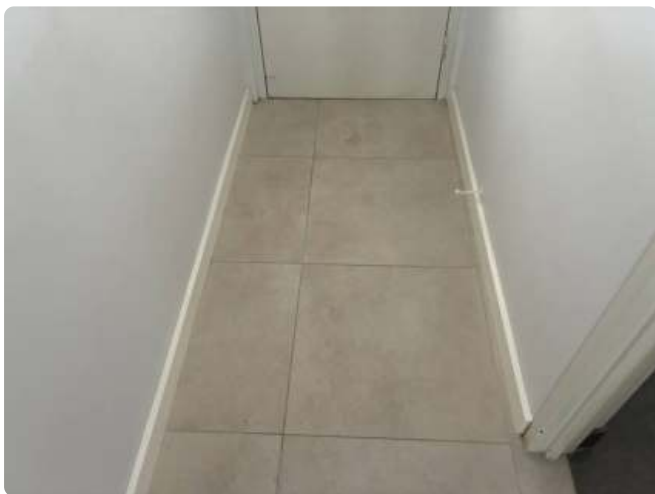
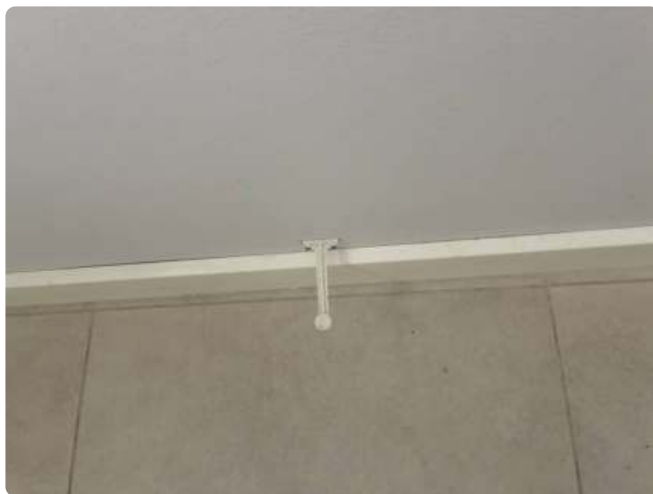
## Hallway - Continued

| Inspector Notes | Minor wall staining visible. No obvious movement or moisture indicators visible. |

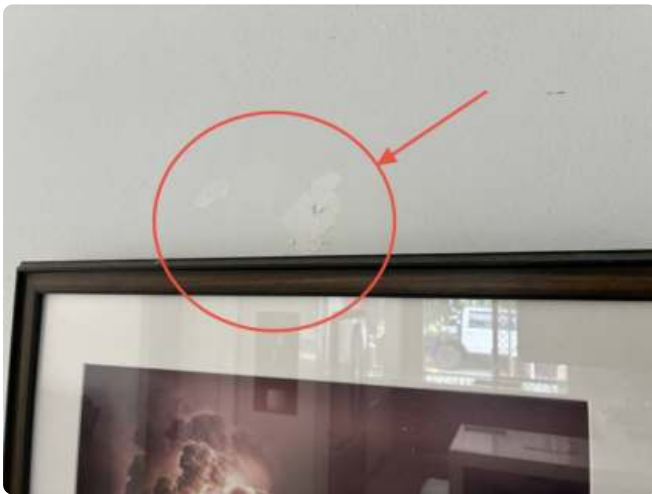
Existing hole that has previously been patched has left the wall discolored.

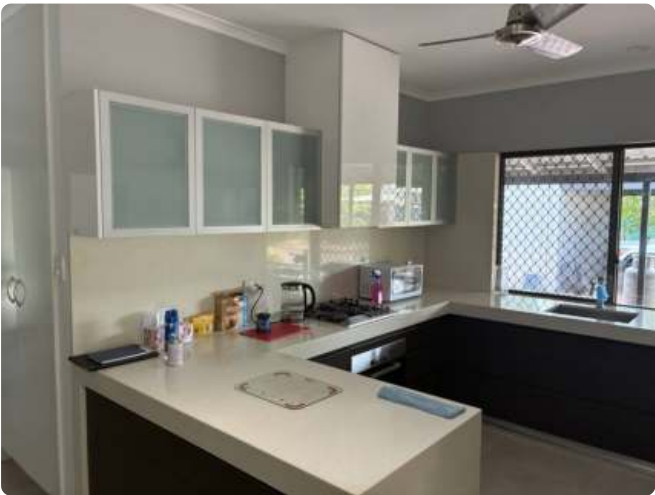
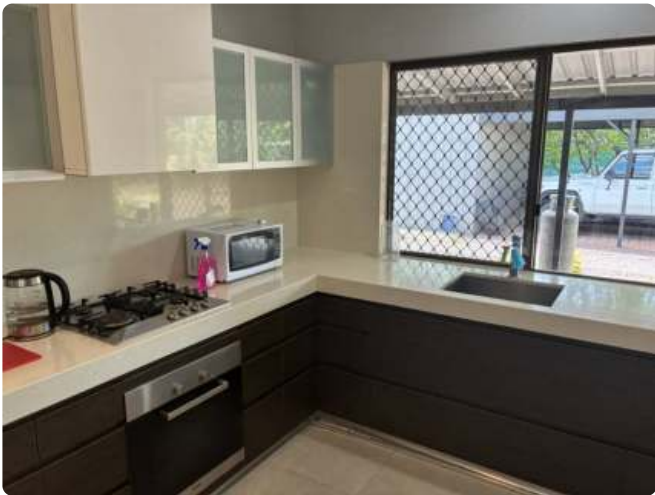
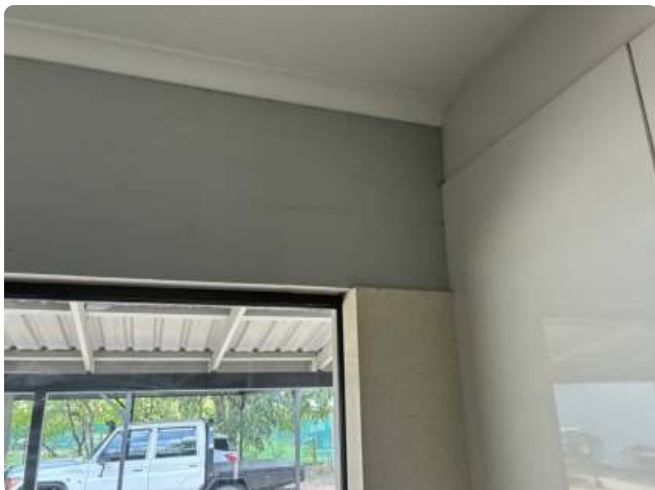
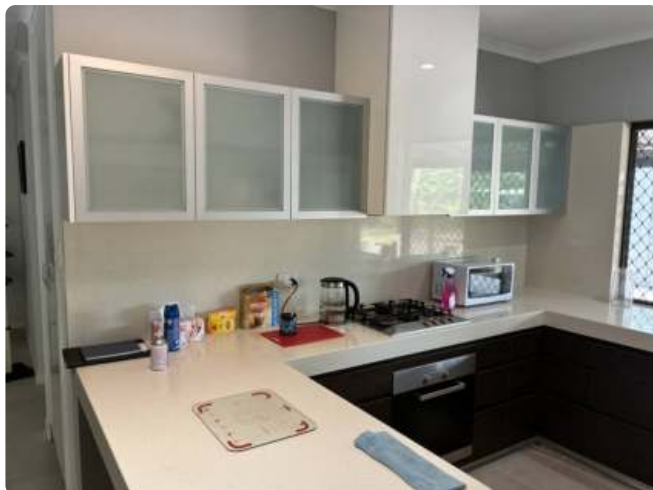
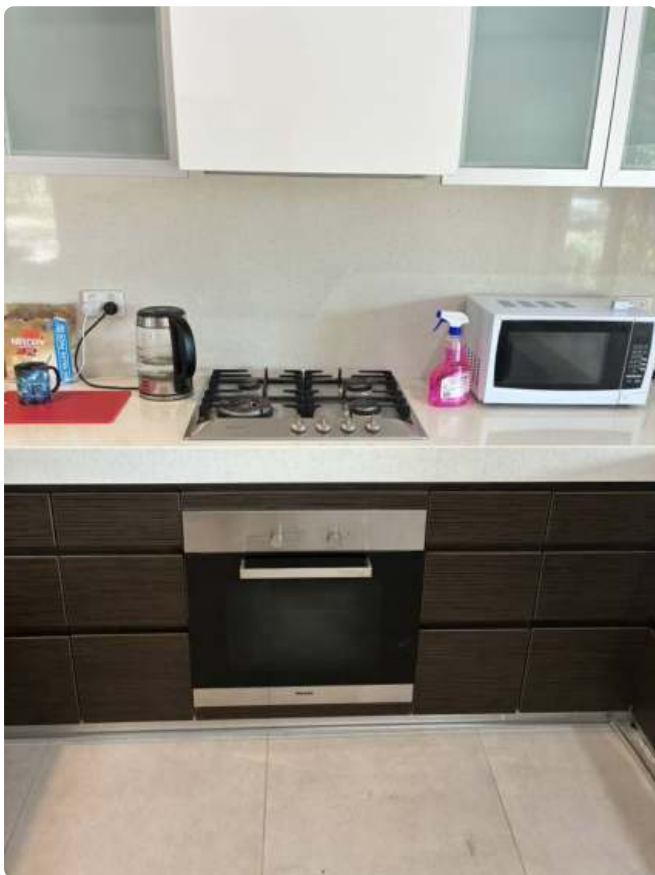
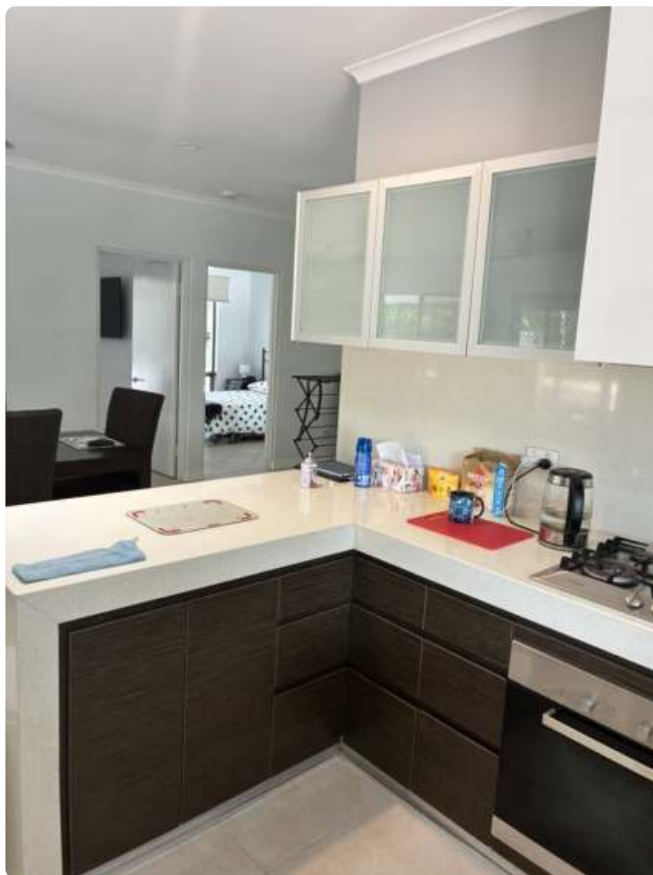
| Inspector Notes | Cabinetry and surfaces displayed minor wear. Some doors appeared misaligned. No moisture testing of cabinets or benchtops performed. |

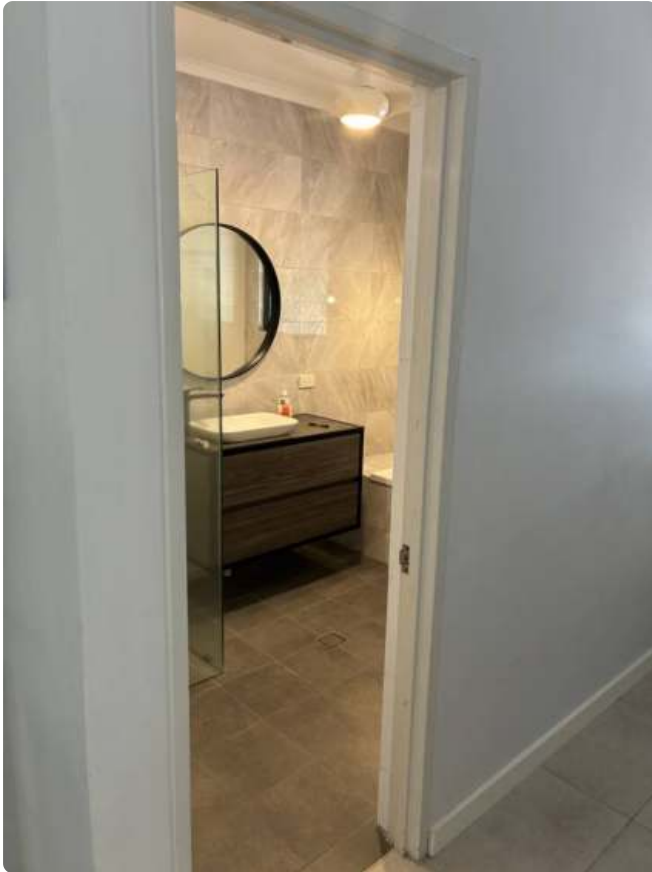
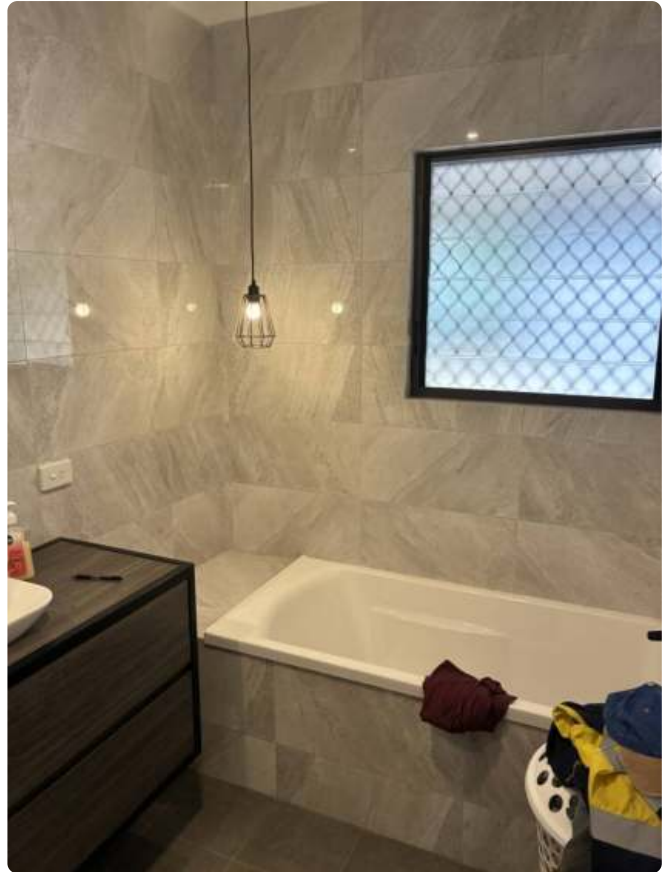
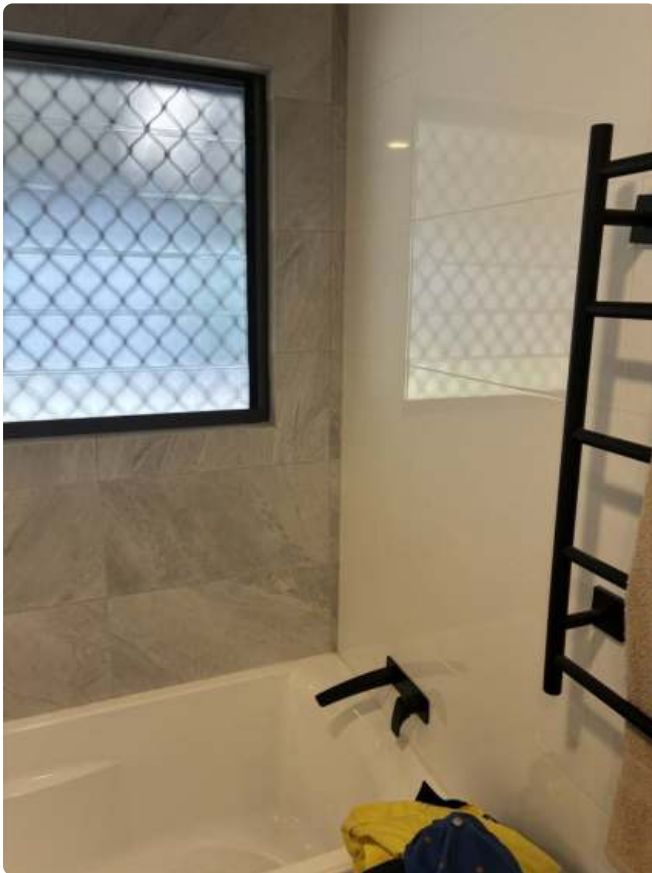
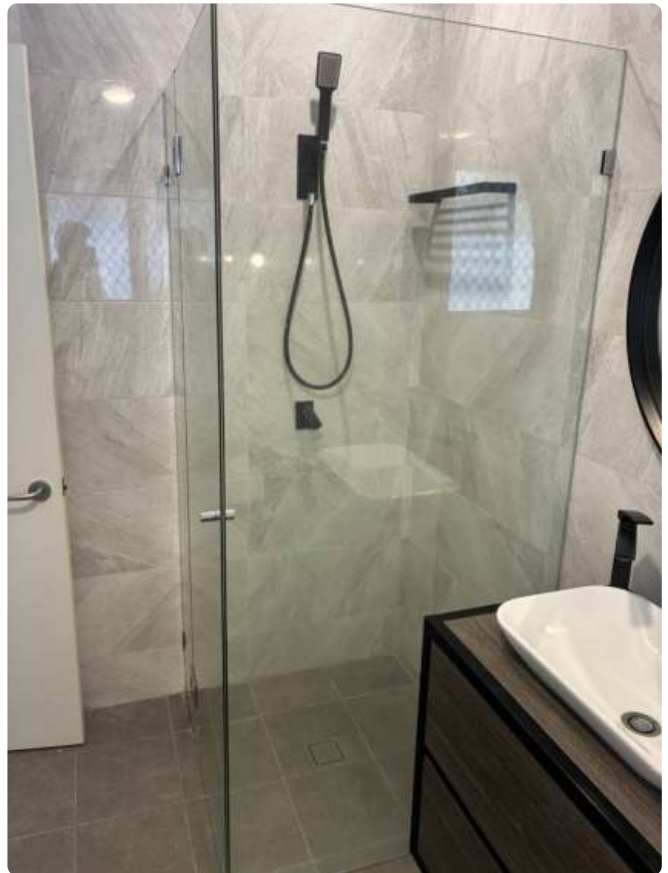
The main bathroom appeared to be in functional condition at the time of the limited visual inspection, restricted to accessible areas. Several Minor Defects were visible, including a shower door that was difficult to operate, localised corrosion at the base of the shower screen, gaps in sections of the corning, and general wear to the door frame. These observations relate to visible surface conditions only and are consistent with age-related use. Routine maintenance by an appropriate trade may assist in improving presentation and function.

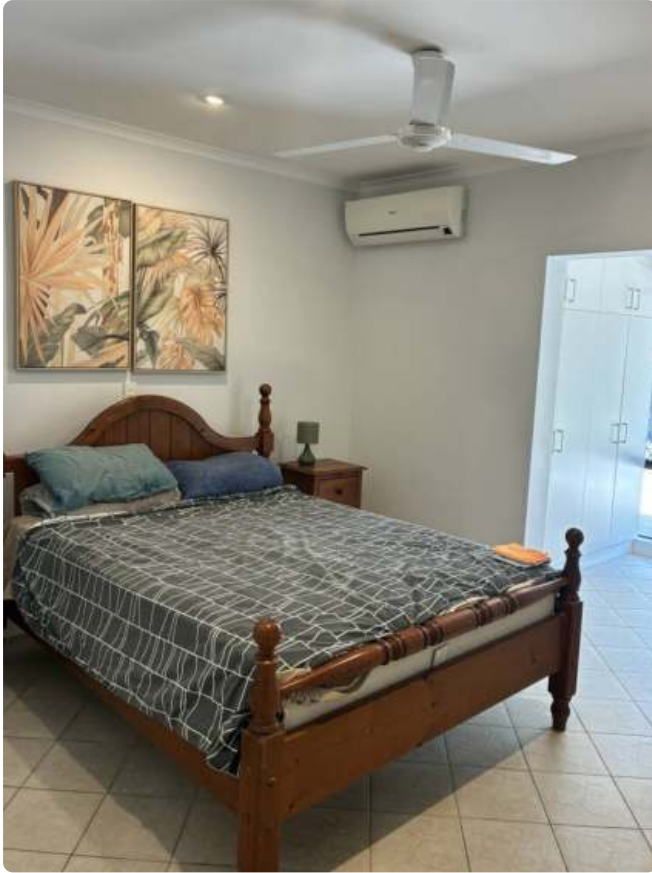
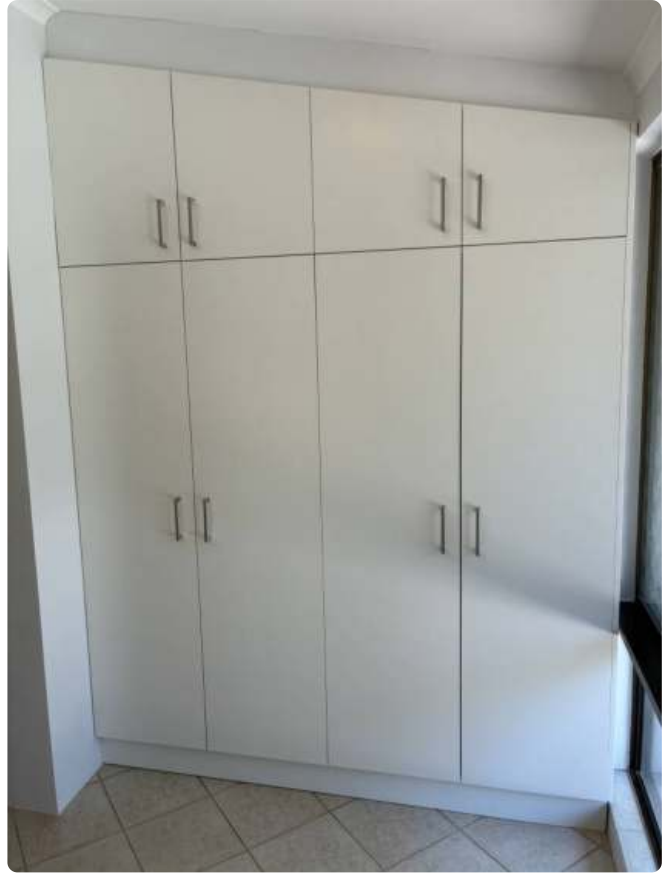
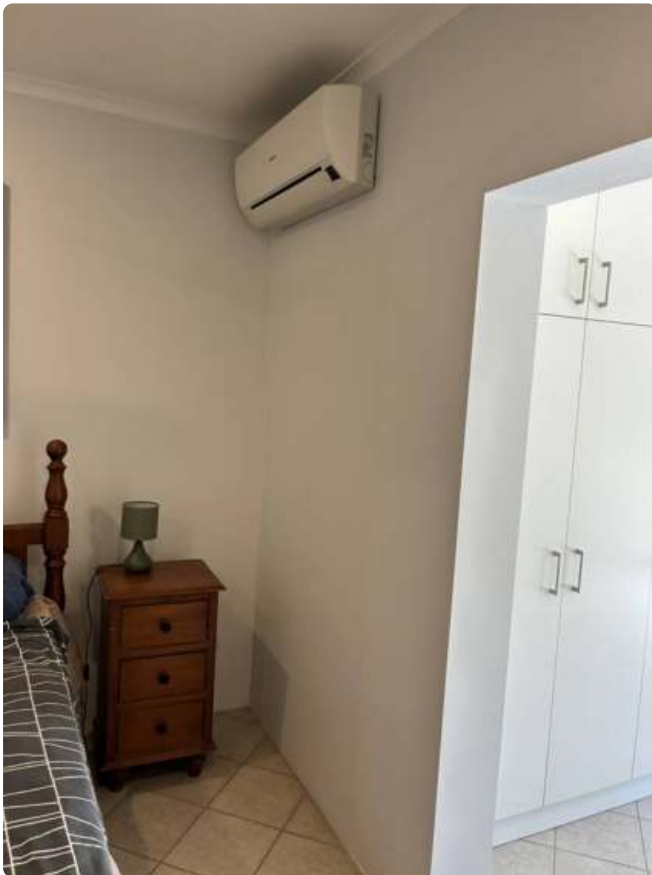
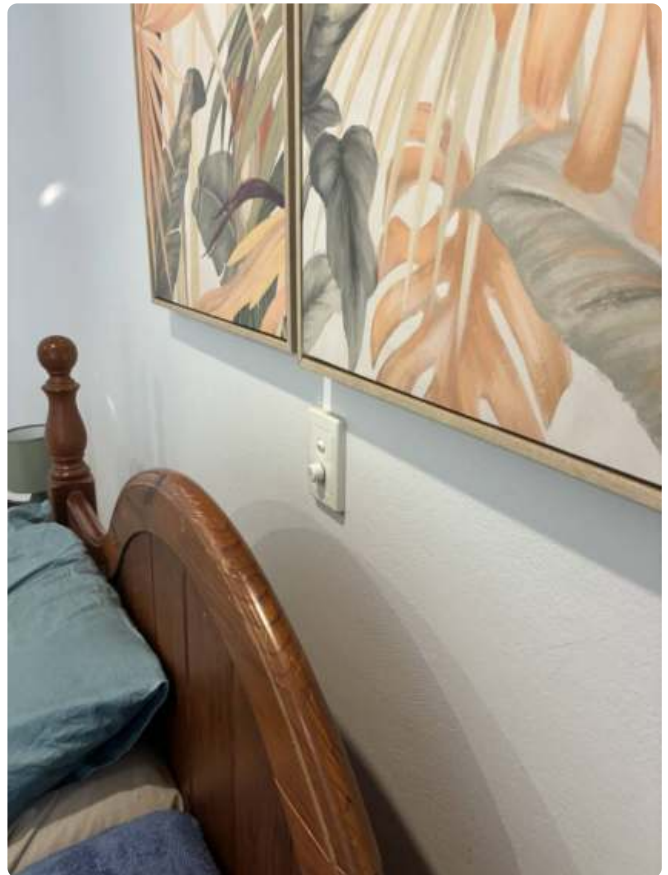
Master bedroom appeared functional at the time of inspection. Notable issues: Visible bowing in the ceiling, this condition may indicate plasterboard deformation or load-related movement, Further assessment by a suitably qualified trade is recommended.

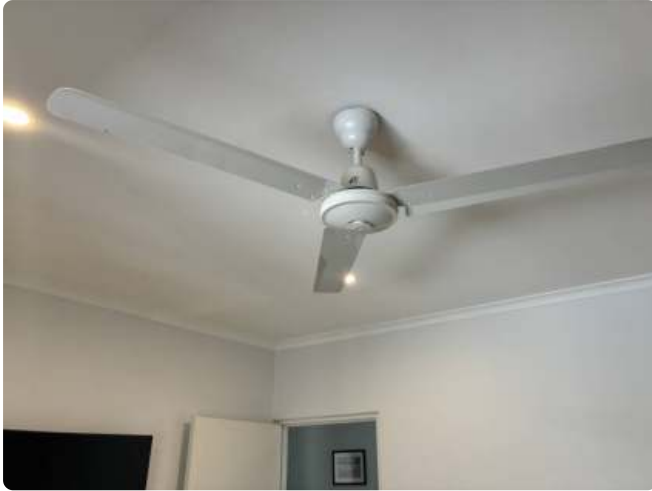
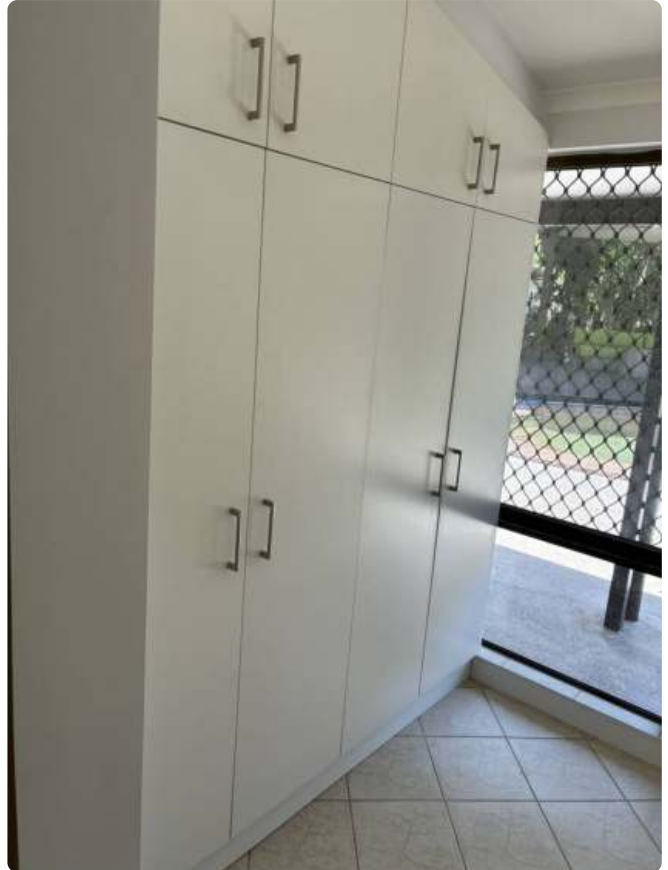
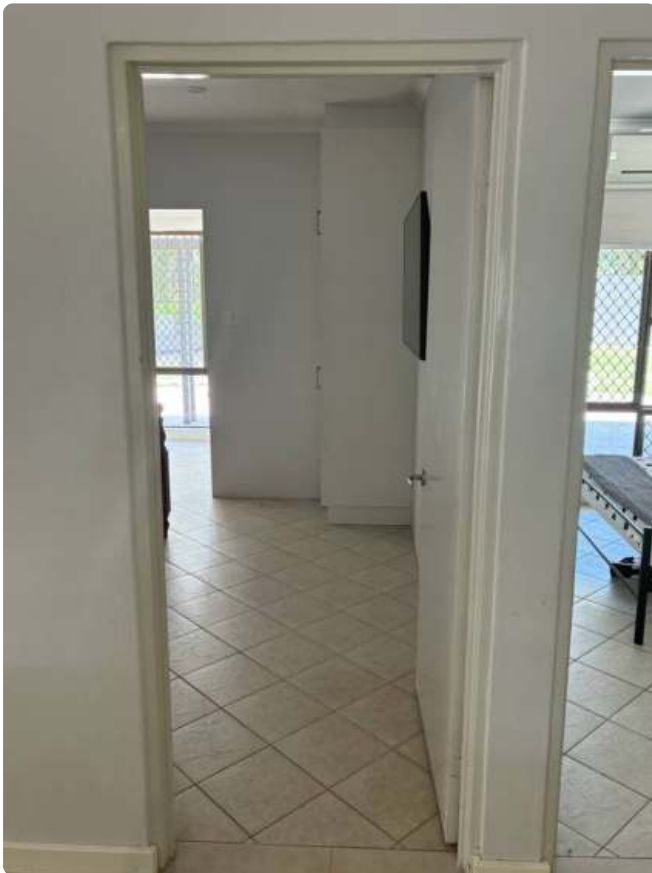
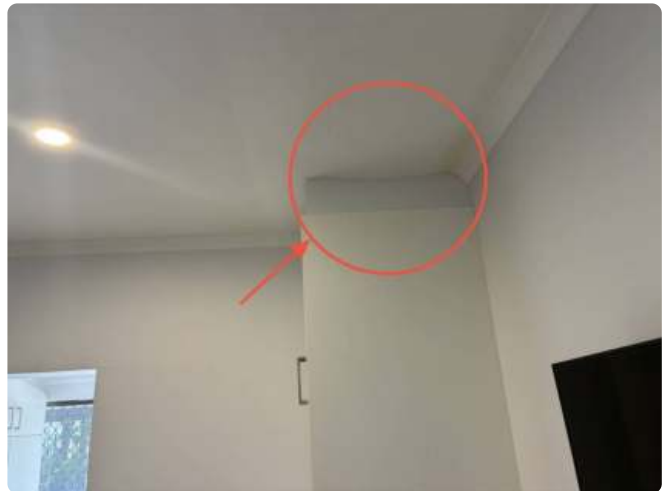
ceiling appears to be bowing around single cabinet.

One Significant Defect noted in the master bedroom ceiling.

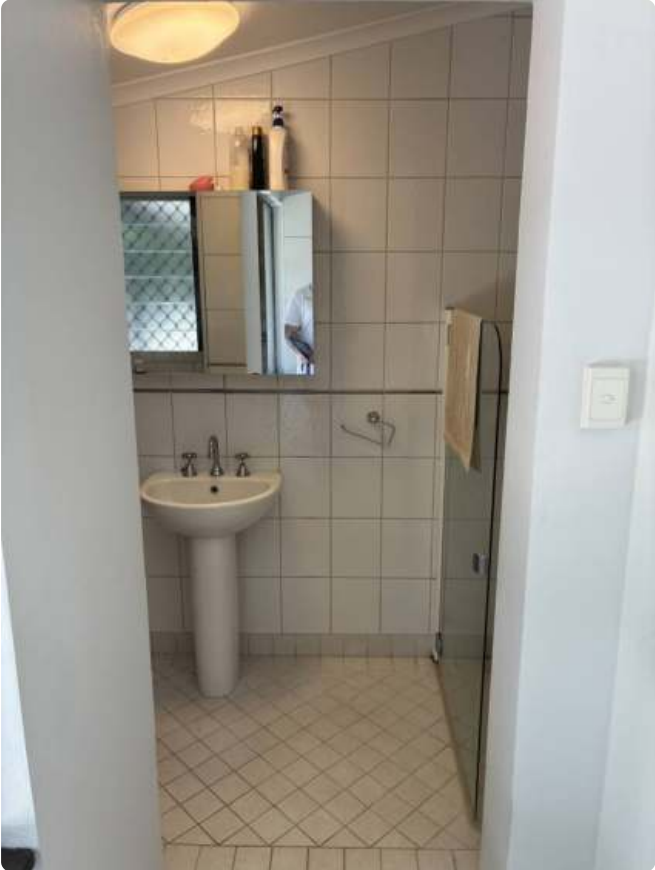
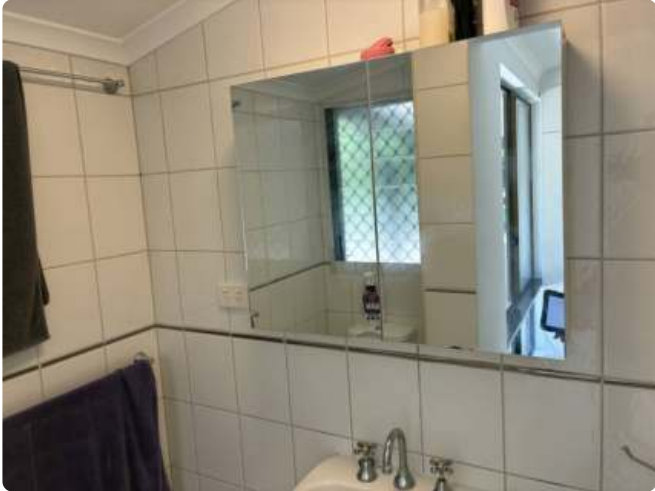
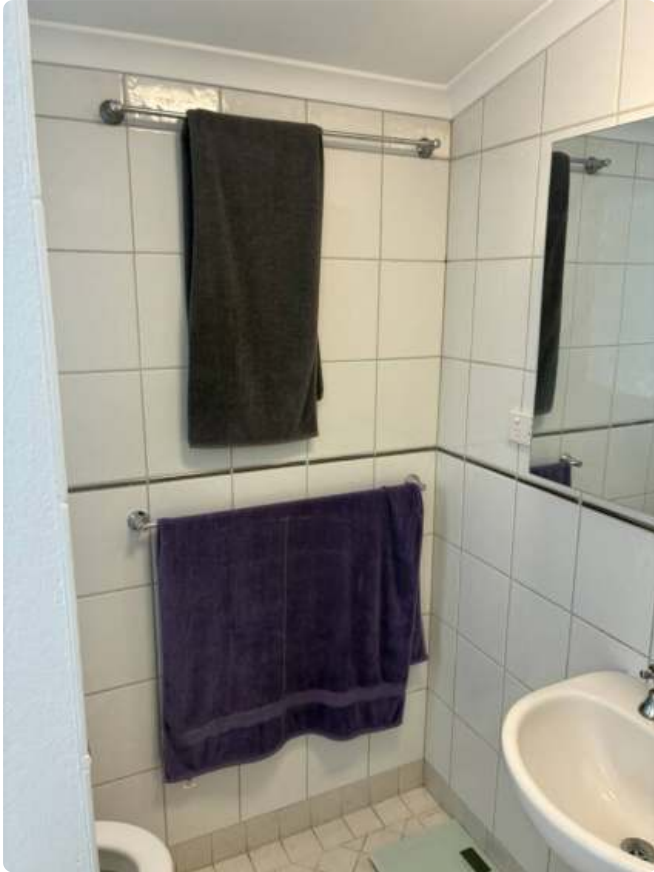
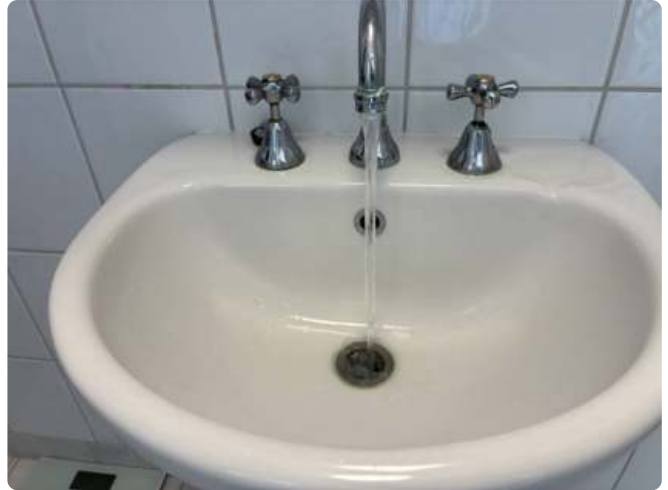
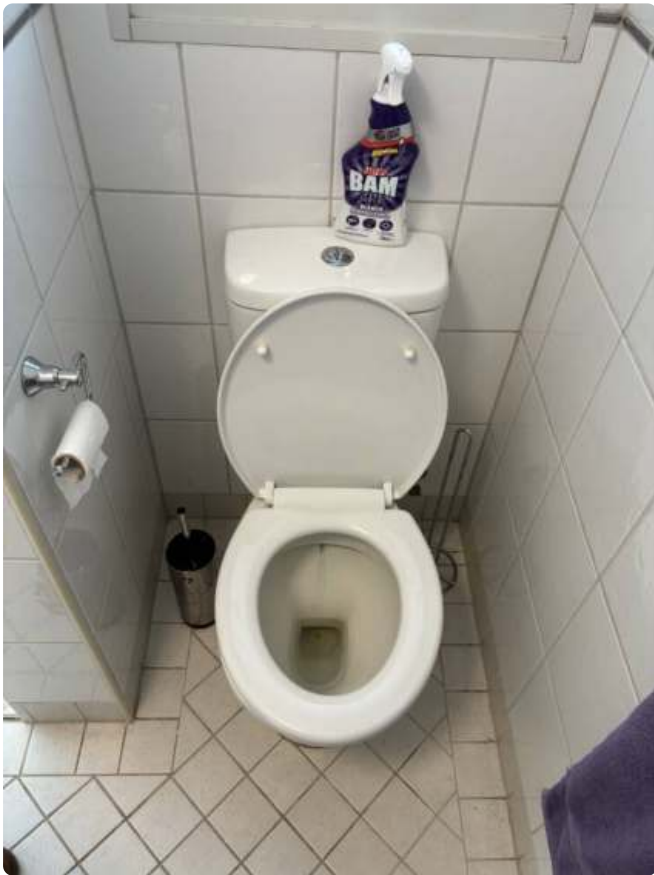
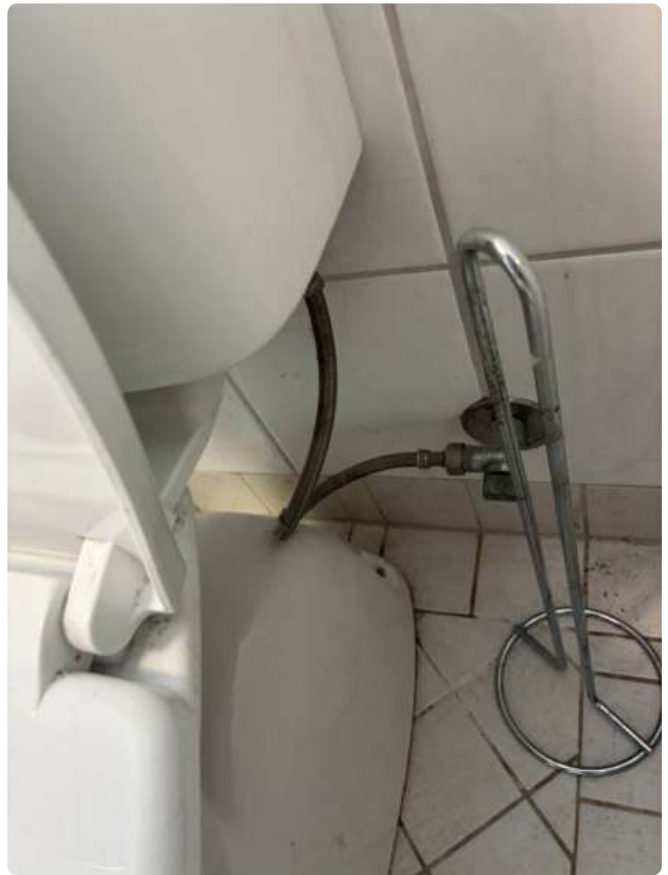
| Ensuite | |
|---|---|
| Inspector Notes | <p>The ensuite appeared to be in functional condition at the time of inspection, based on a limited visual assessment of accessible areas. A Significant Defect was identified in the shower wet area, where multiple cracked tiles were visible, particularly around the drain.</p> <p>Cracked tiles in a wet area present a potential moisture-ingress risk based on visual symptoms only; any concealed deterioration cannot be determined without invasive assessment. The shower screen was also heavy to operate and made contact with the basin when opened, indicating possible misalignment or hinge wear. Further evaluation and rectification by a suitably qualified tiler or waterproofing trade is recommended. No waterproofing or substrate assessment was undertaken.</p> |

One Major Defect was identified in the ensuite wet area.

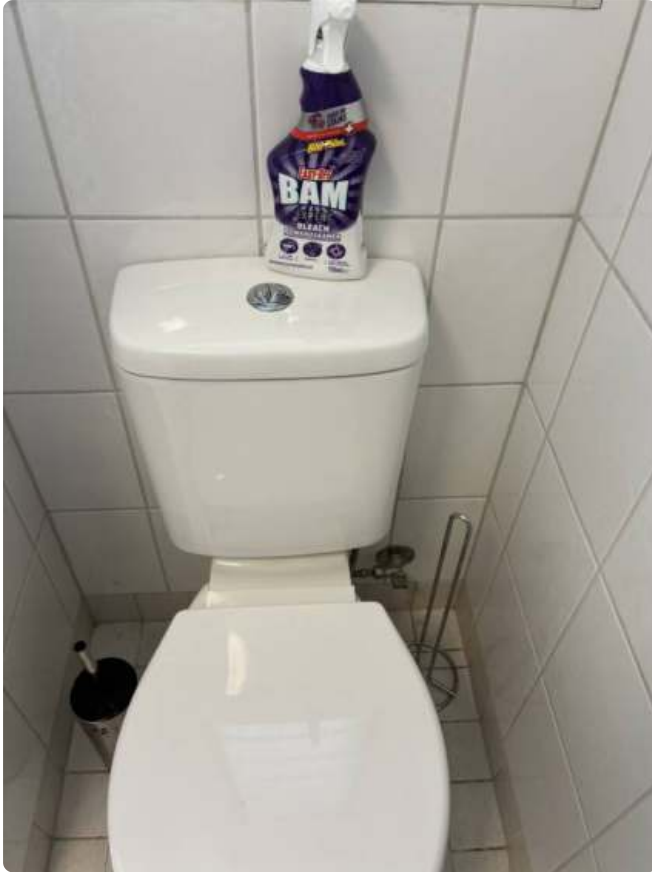
Half flush button doesn't work.

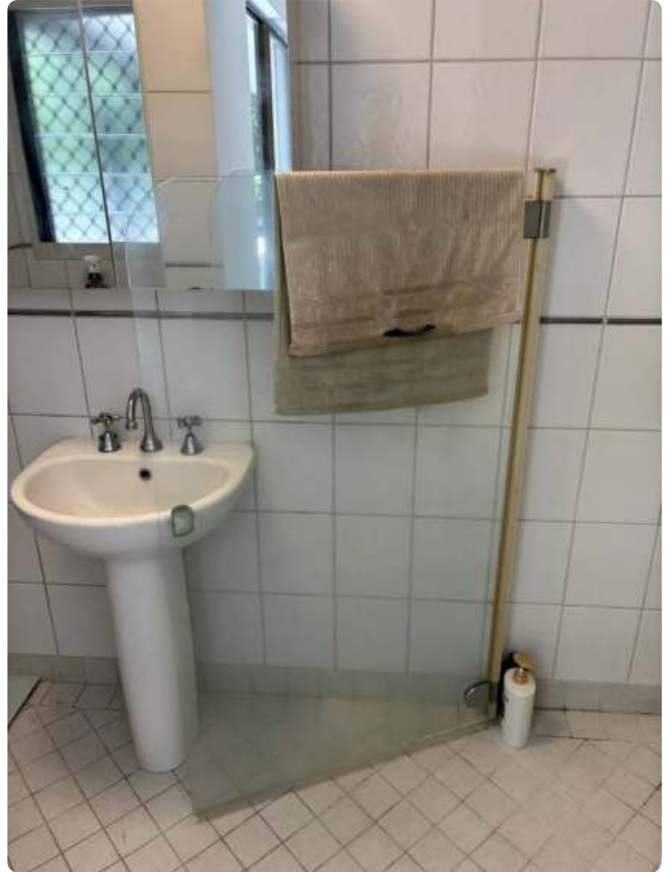
Screen door is stiff and heavy to open.

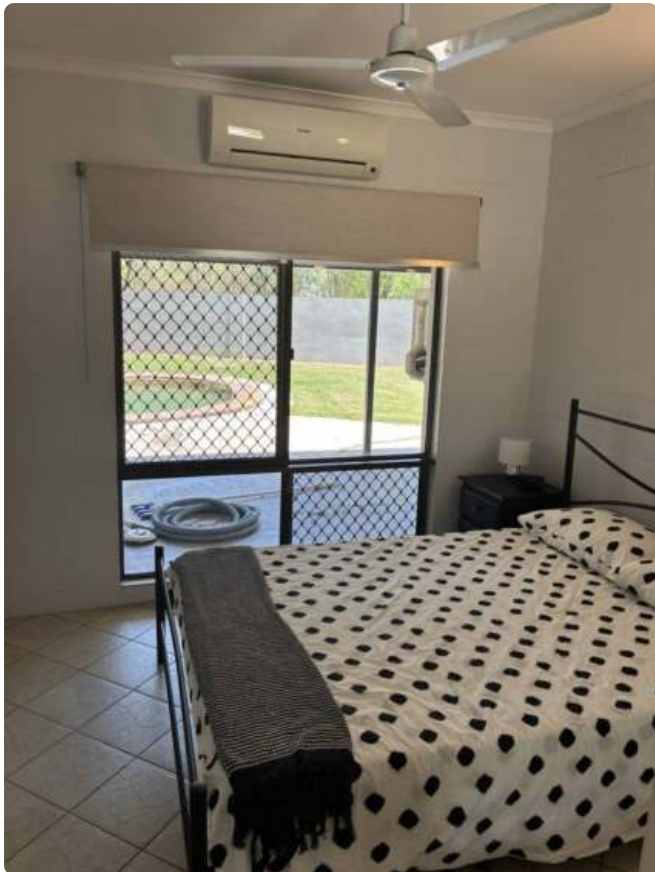
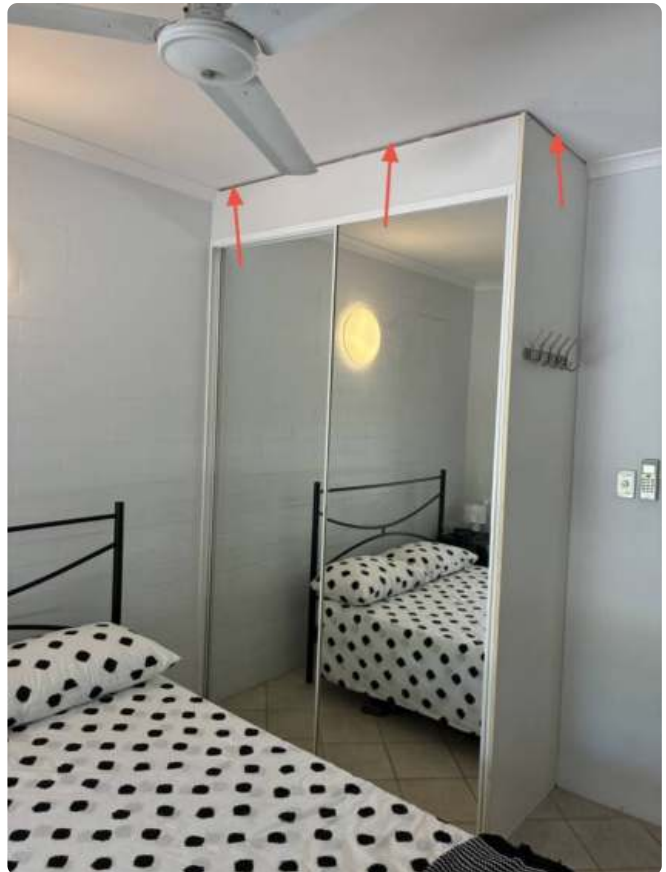
Noticeable gaps between wardrobe and ceiling.

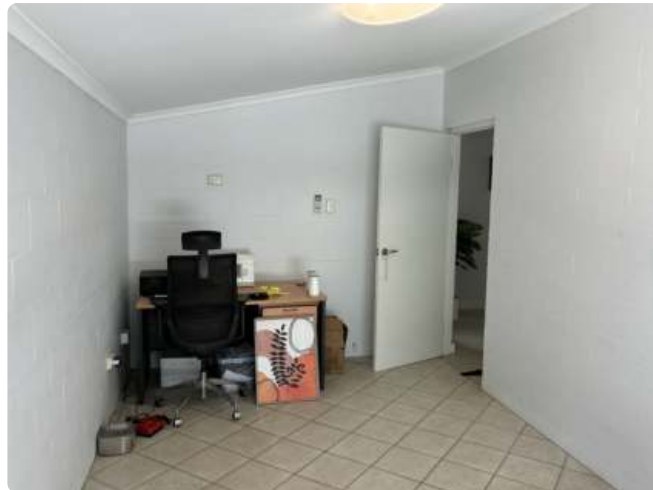
Minor staining on wall and door frame.
