# **BUILDING INSPECTION & CONDITION REPORT**

12 Brumby Court, Marlow Lagoon NT 0830

25th November, 2025

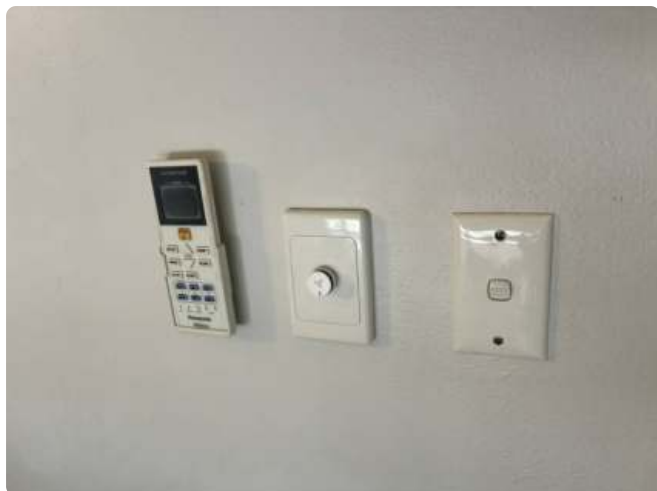
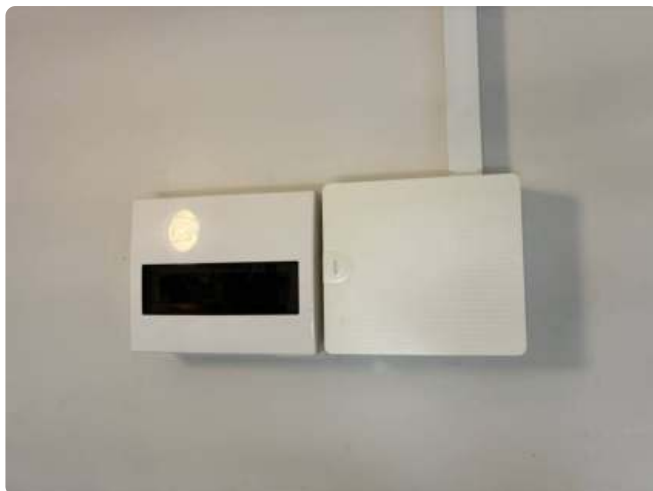
Switchboard located in the bedroom.
